Lake Steilacoom Bridge Repair Update

City of
Lakewood

Current Bridge Condition Summary

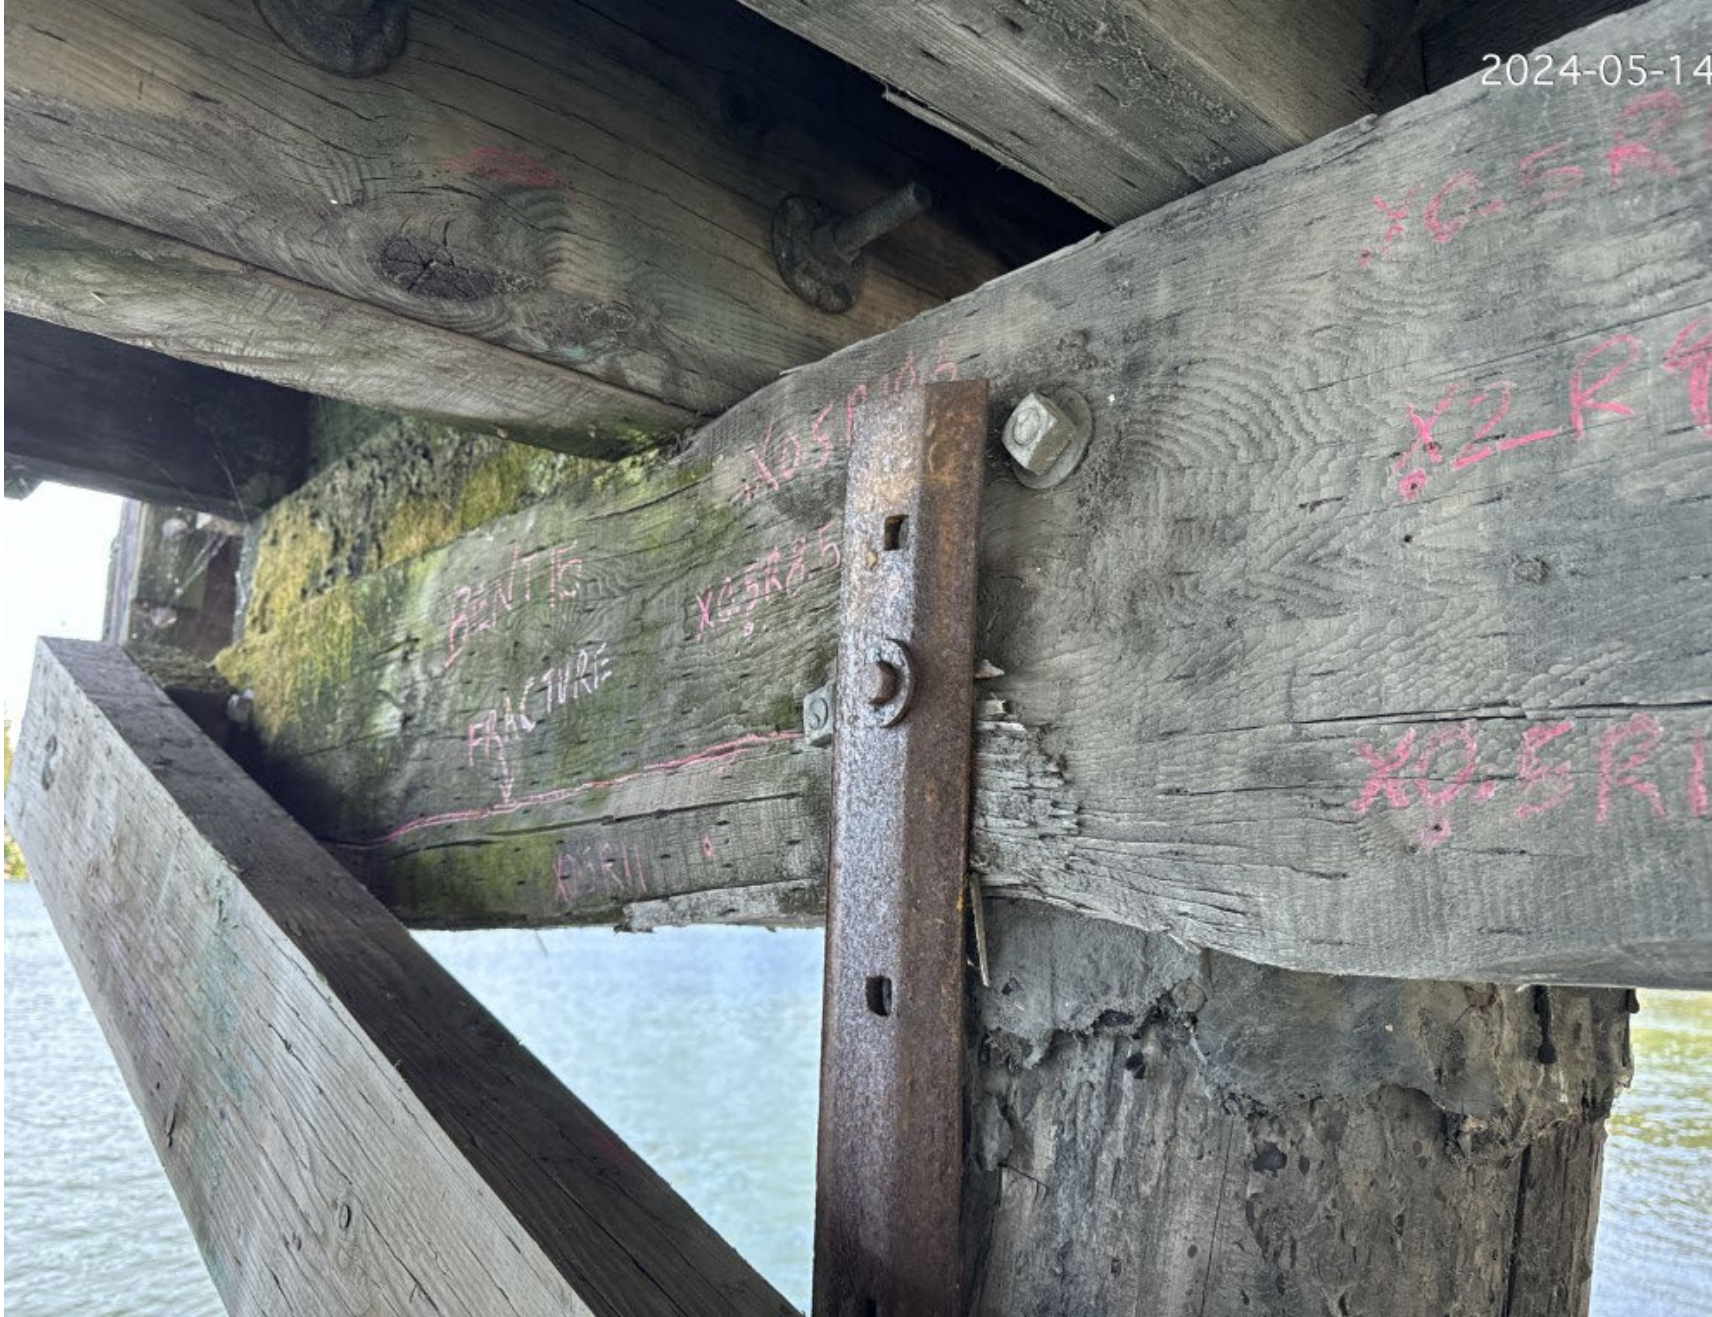
Pile Cap Failure

Cap is pulling the deck down in this condition, causing harm to surrounding members

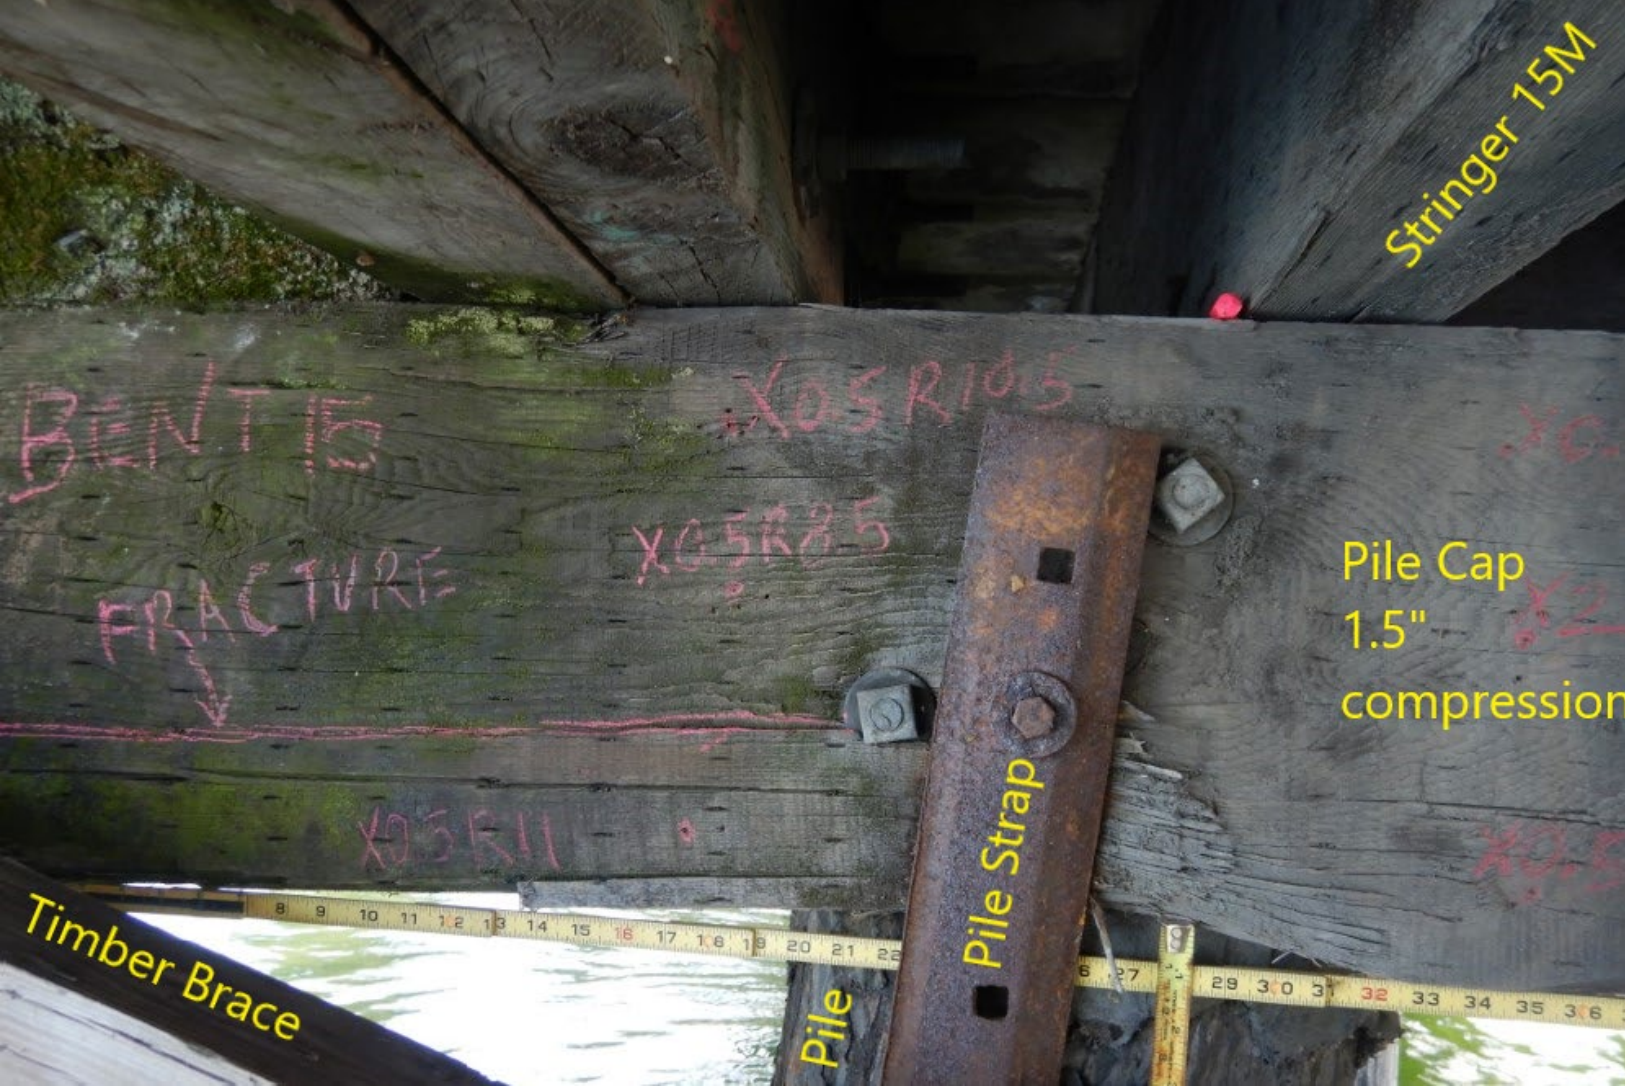
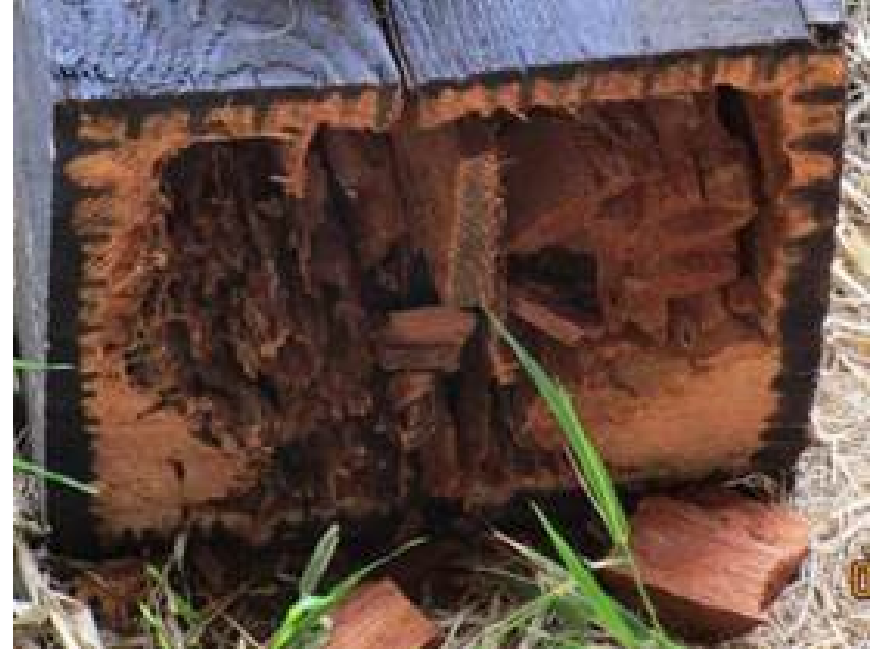
½" Shell thickness in Pile Cap 15 caused a 1.5" compressive failure. Photo to the left shows the compression on the cap of Bent 15 on May 14, 2024. Photo above is a representation on the interior condition of the pile cap.

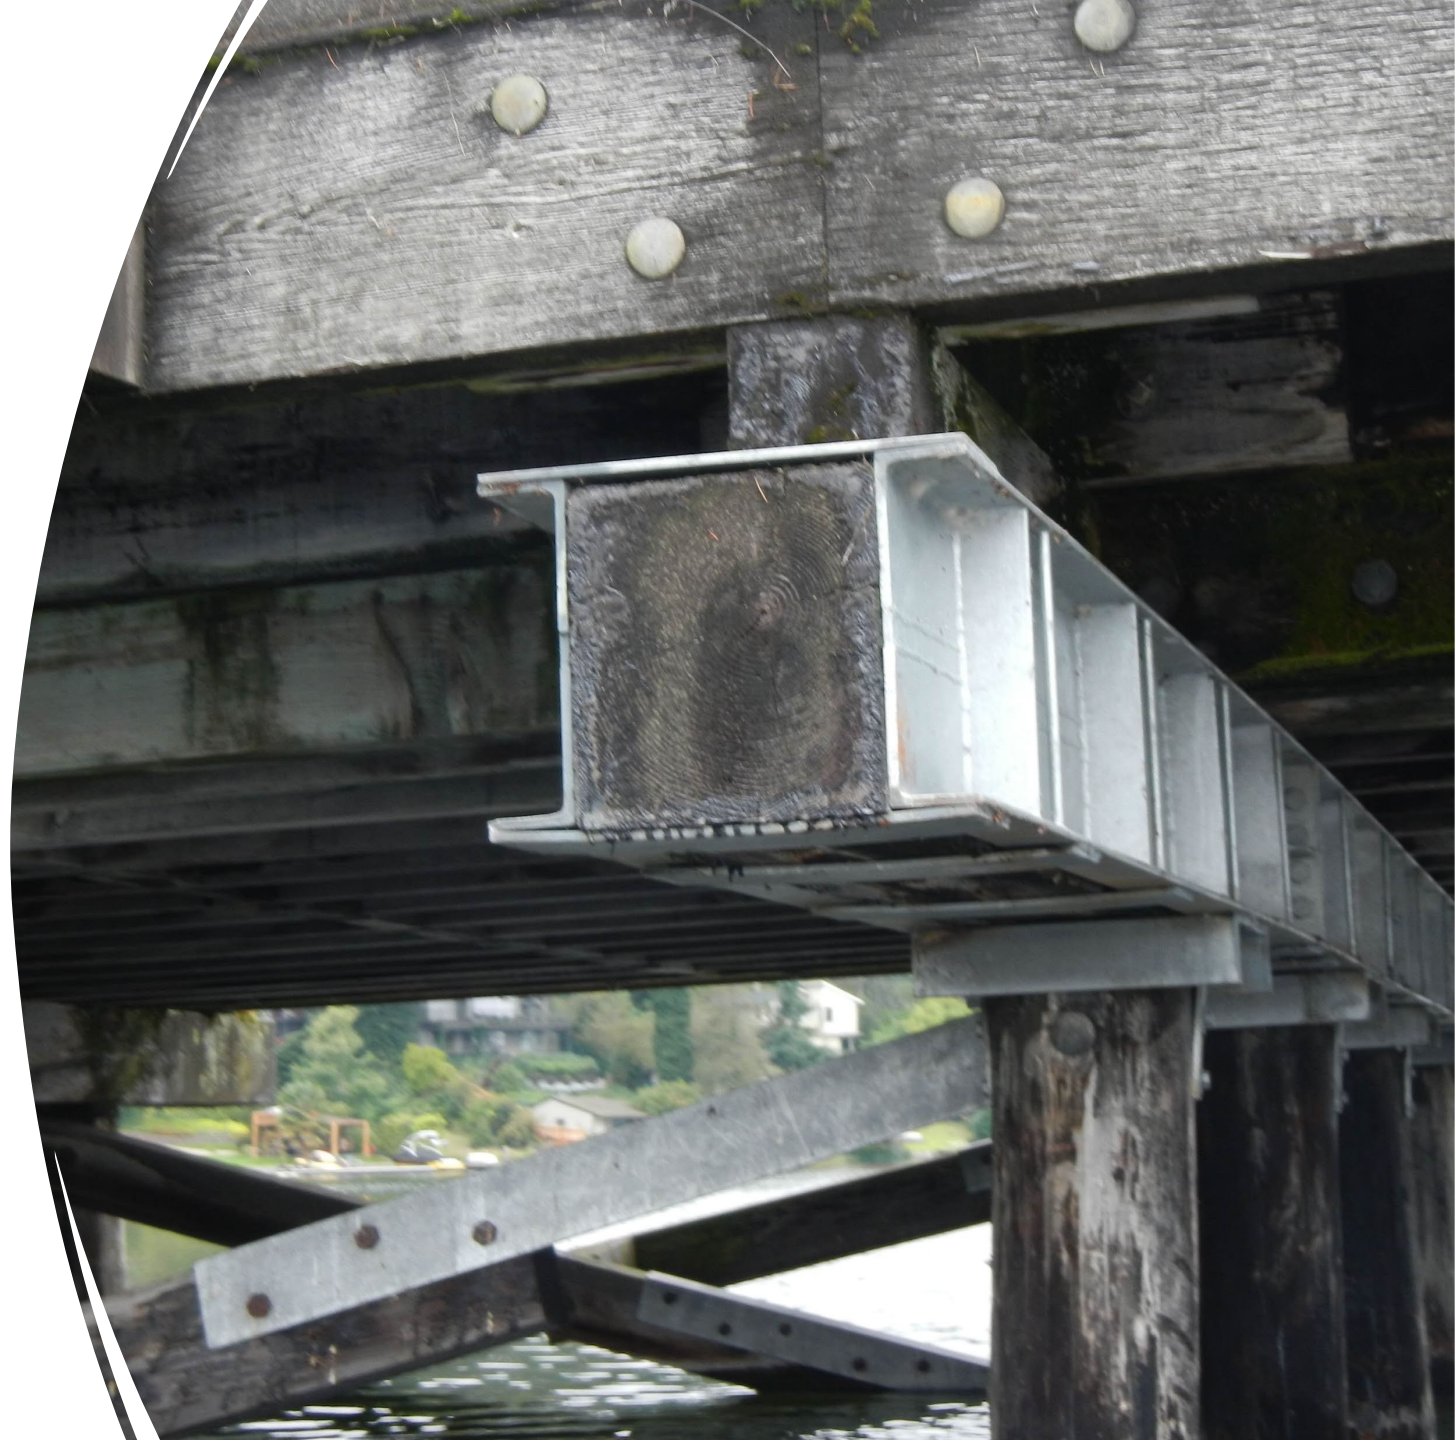
Pile Cap Replacement in 2013 – Steel Encapsulation

WSDOT performed a steel encapsulation of the cap on Bent 4 in 2013. It is expected that the cost for this treatment will be much more significant than the replacement of the timbers. Additionally, material is not available during the current fish window.
