American Lake Eurasian Milfoil Program 2019 Year End Report

Prepared for
City of Lakewood

AquaTechnex,
LLC

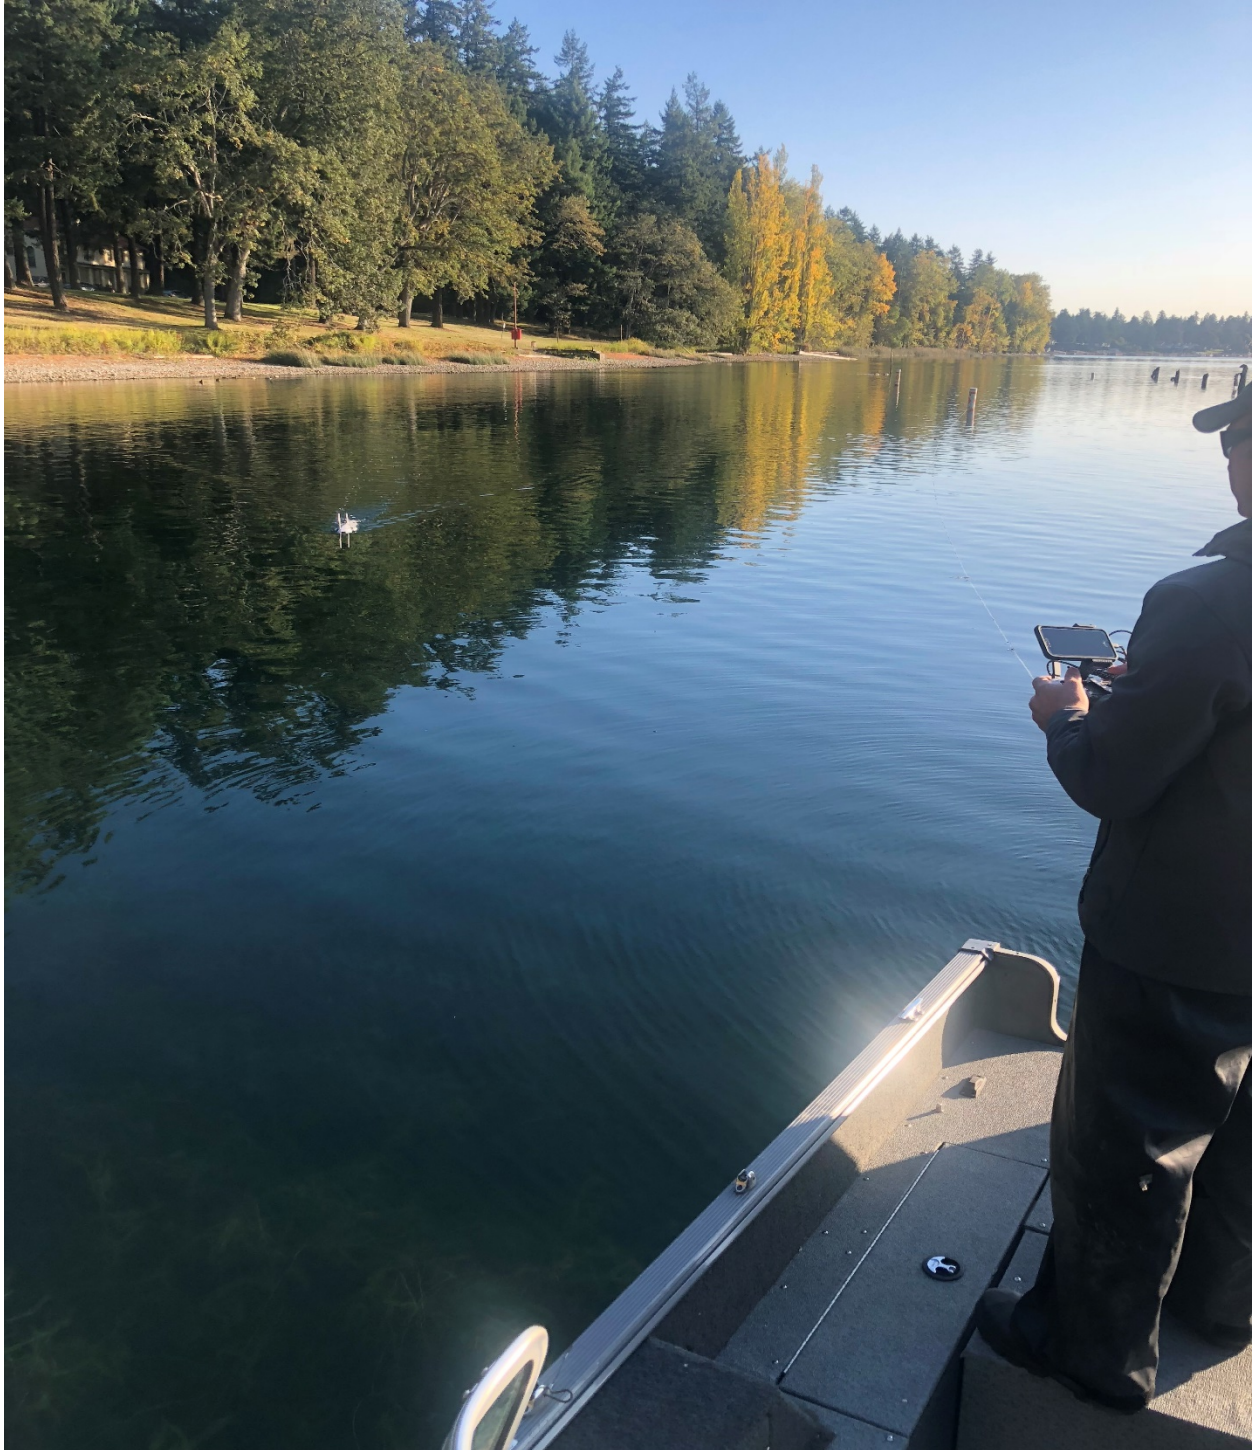
Aquatechnex biologist deploying 4k video drone system. This system has 4K resolution camera, is controlled by handheld system and is steered to locations to video or runs programed transects.

The second review and survey of the lake took place on October 9th. We mobilized a survey team equipped with an underwater video drone system to the lake so that observations of our team could be recorded for display to the City in this report.

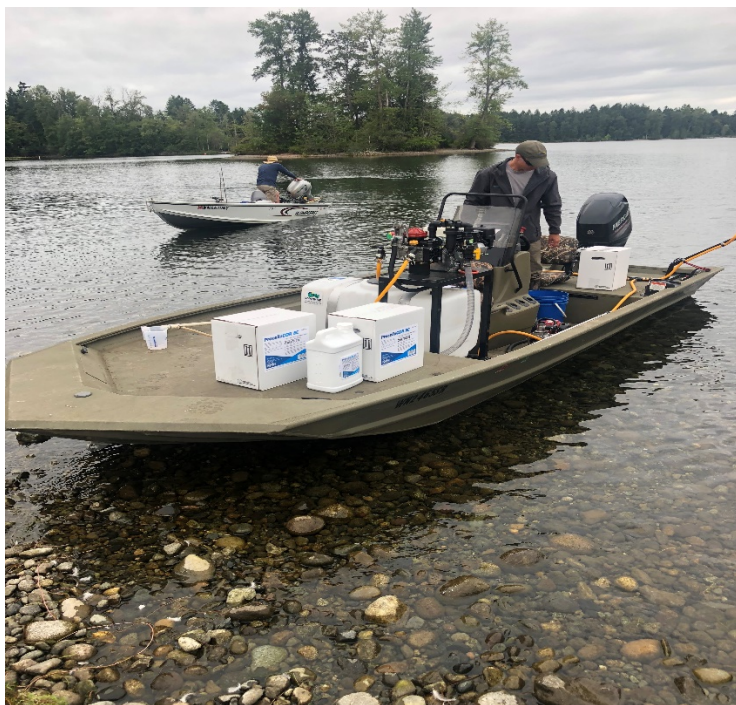
Boom jet system designed to apply ProcellaCOR at water surface used on American Lake Project

The one new system used a surface spray boom-jet system that applied the herbicide right on the water surface. This boat did all of the work in the western portion of the lake where control is not as rapid. There is a distinct line where the one boat stopped, and the new boat started.

This is a new herbicide and people are still learning about it in the field. One theory might be that the herbicide that was surface applied absorbed very high in the plants, at the lake surface and damage causes may have limited translocation. The boom systems that injected may have more rapidly exposed more of the plant vertically in the water column and absorption occurred at more points on the plant stem vertically in the water column.

But the primary factor that differentiates control is the boats that worked on the lake. This boat was built specifically to address where the manufacturer wanted to put the herbicide in mid to late summer, and it may be that it doesn't work as well as the drop hose system in terms of exposing the plant in the water column to the herbicide. While this is an opinion, it seems well founded.

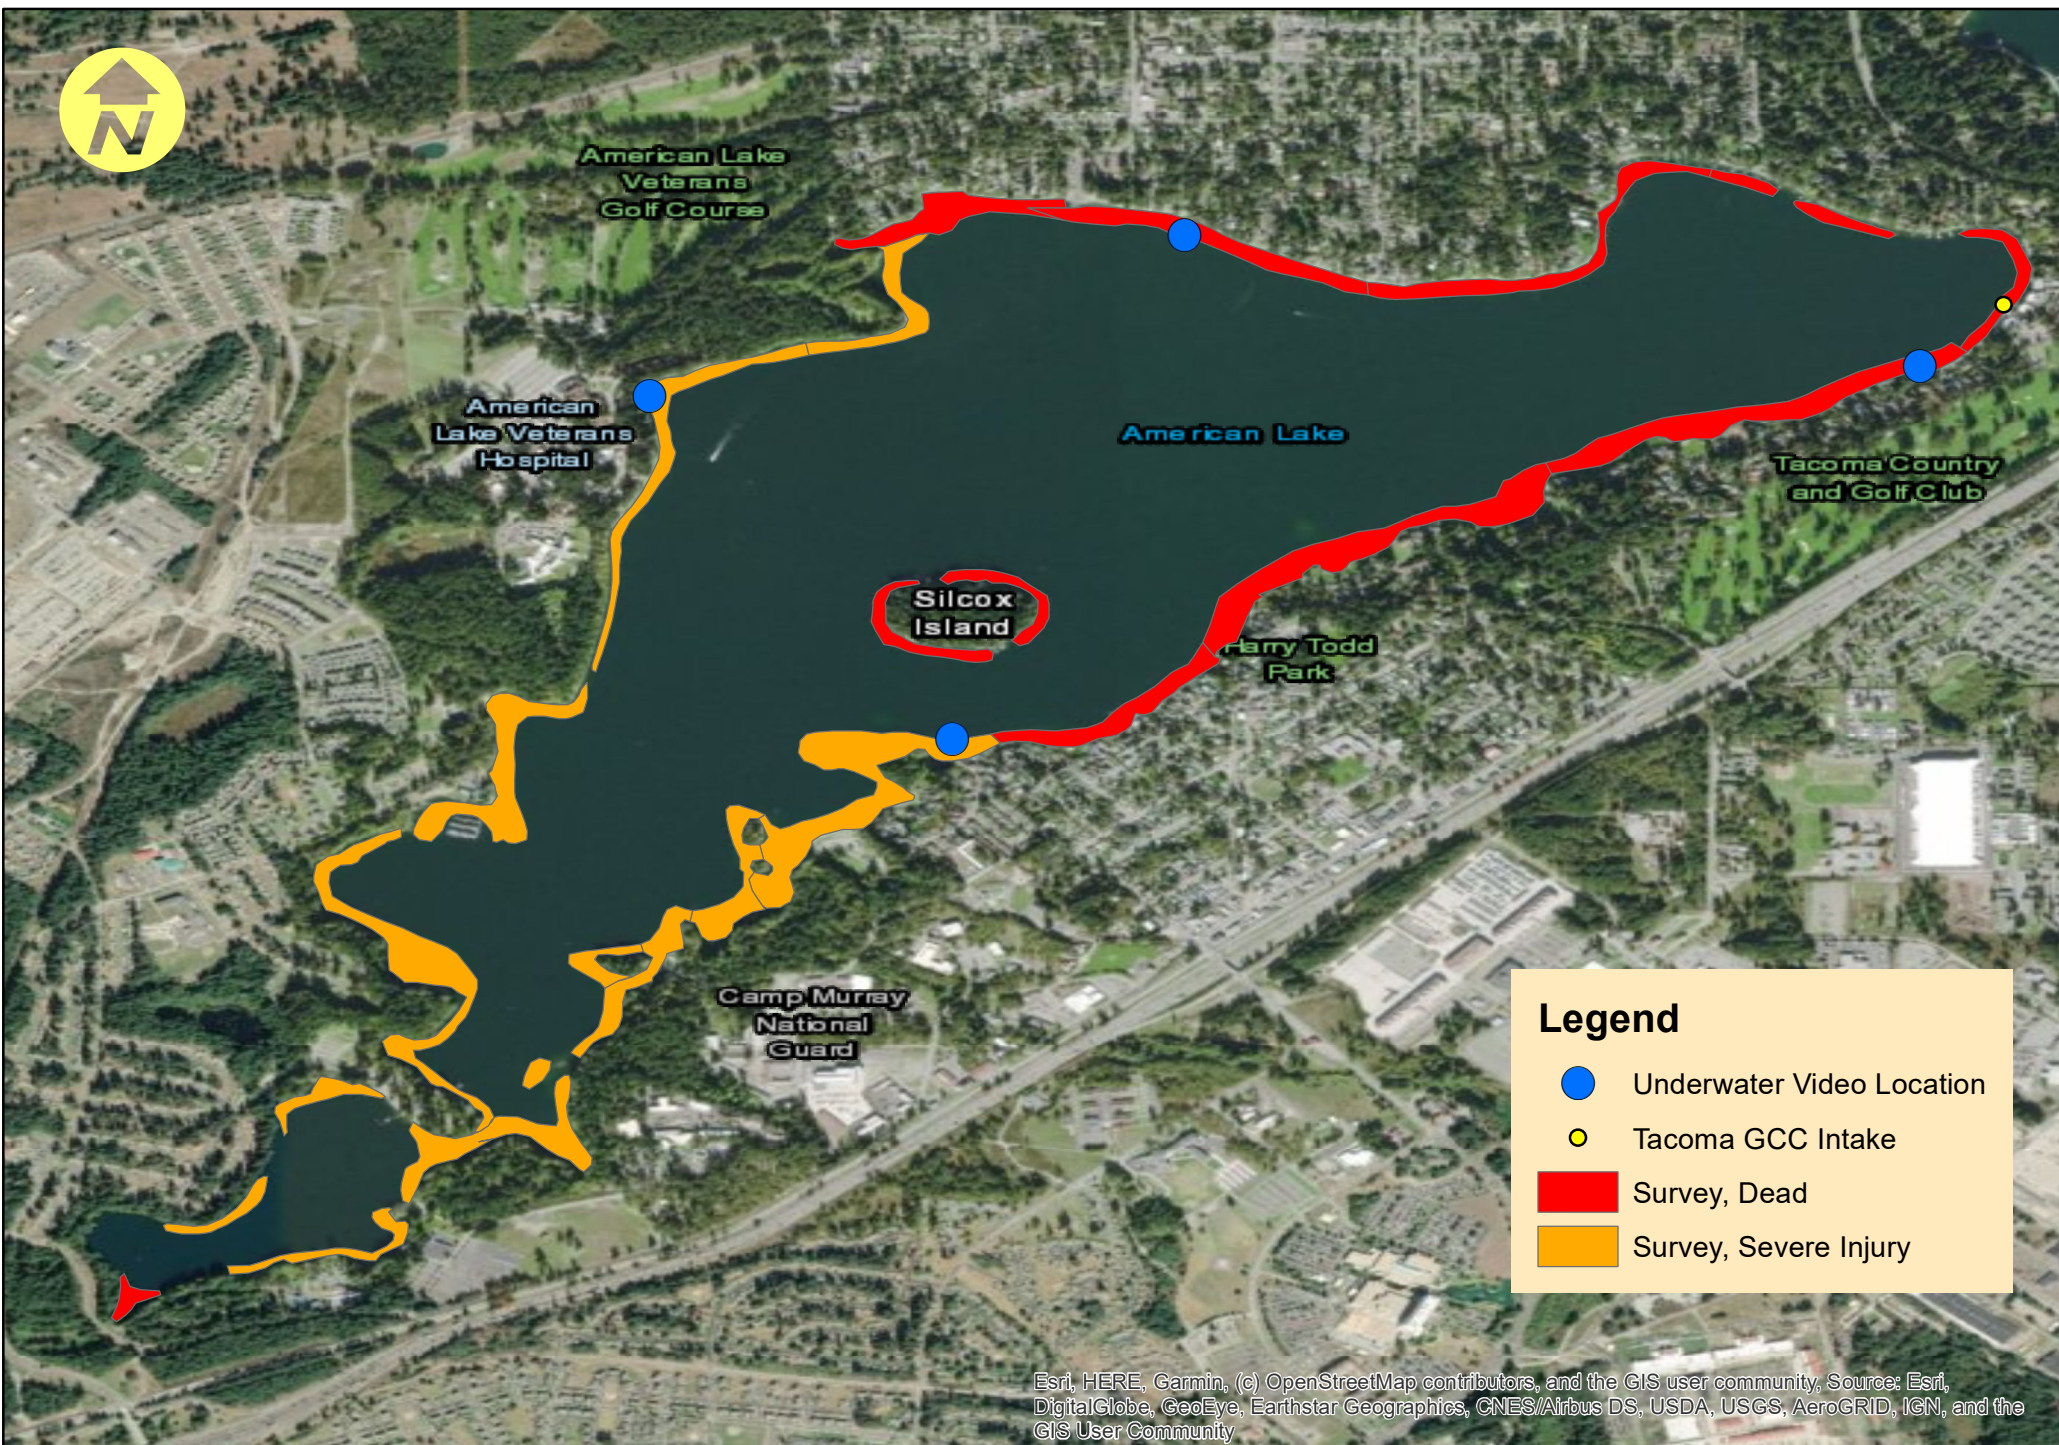
American Lake Eurasian Milfoil Treatments, Summary of Control

The first map is of the treatment areas that were subject to herbicide application. The second map provides an overview of conditions in the lake at approximately two months post treatment.

Zone one is labeled Milfoil Dead. The milfoil beds in this zone are dead and gone from the water column. There are however significant levels of native aquatic plant growth present. Potamogeton species and Vallisneria were the dominant species present. These plants while present are not the

Zone two is labeled severely injured. Plants in this zone all showed herbicide symptomology, all stems 6-8 feet below the water line level on day of treatment, more than half of the stems laying over and defoliated. There was also green growth remaining on the stems in perhaps 50% of the plants present in this zone (all stems however showed herbicide impacts). Two representative underwater videos are presented here:

In the spring of 2020, starting in mid-May, the lake should be inspected to determine if there is regrowth in the areas mapped as injured.

Our contract expires at the end of this year. If it is renewed, and there is significant regrowth in the areas mapped as severely injured, we would offer to perform a second application to these zones providing the herbicide and the application equipment and team to finish this off at no additional cost.
