# City of Lakewood Street Ends Water Access Concept Designs Technical Memo

City of Lakewood –
Parks, Recreation and Community
Services
Mary Dodsworth, Director
Stacey Reding, Capital Projects

To: Coordinator
Date: 11-22-2022
City of Lakewood Street Ends Water Access
From: J. A. Brennan Associates, PLLC
Project: Concept Designs

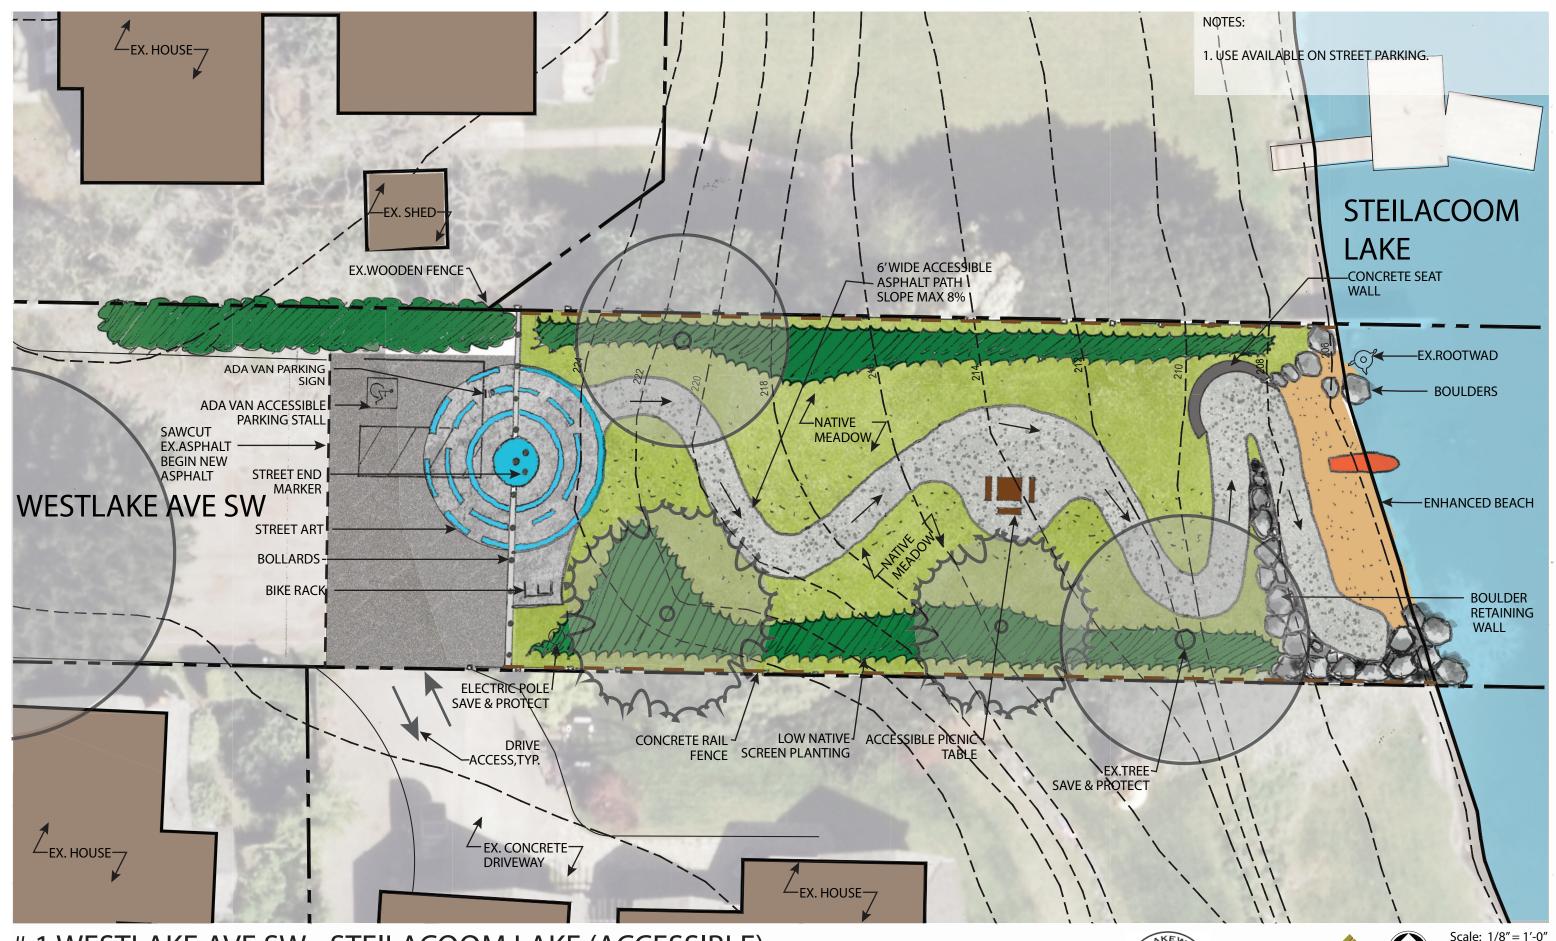
# 1 WESTLAKE AVE SW - STEILACOOM LAKE (ACCESSIBLE)

- 5. The street end marker is centrally located to align with the street's center line, creating a visual connection to the site
- 6. Traffic-rated bollards are proposed to replace the existing guardrail and open the site lines to the street end space

- 10. A secondary moment is offered at the shore edge with a small concrete seat wall feature before accessing the beach.
- 11. Beach enhancements include adding a blended rounded gravel rock mix of 1" diameter to pea gravel-sized material placed above OHW. Habitat boulders are proposed as informal seating elements and beach features.

- 12. Landscape improvements include invasive removal and native plant restoration at the site's edges. The plant palette will be limited to low-growing shrubs such as sword fern, salal and snowberry. Primary restoration will be native meadow seed.

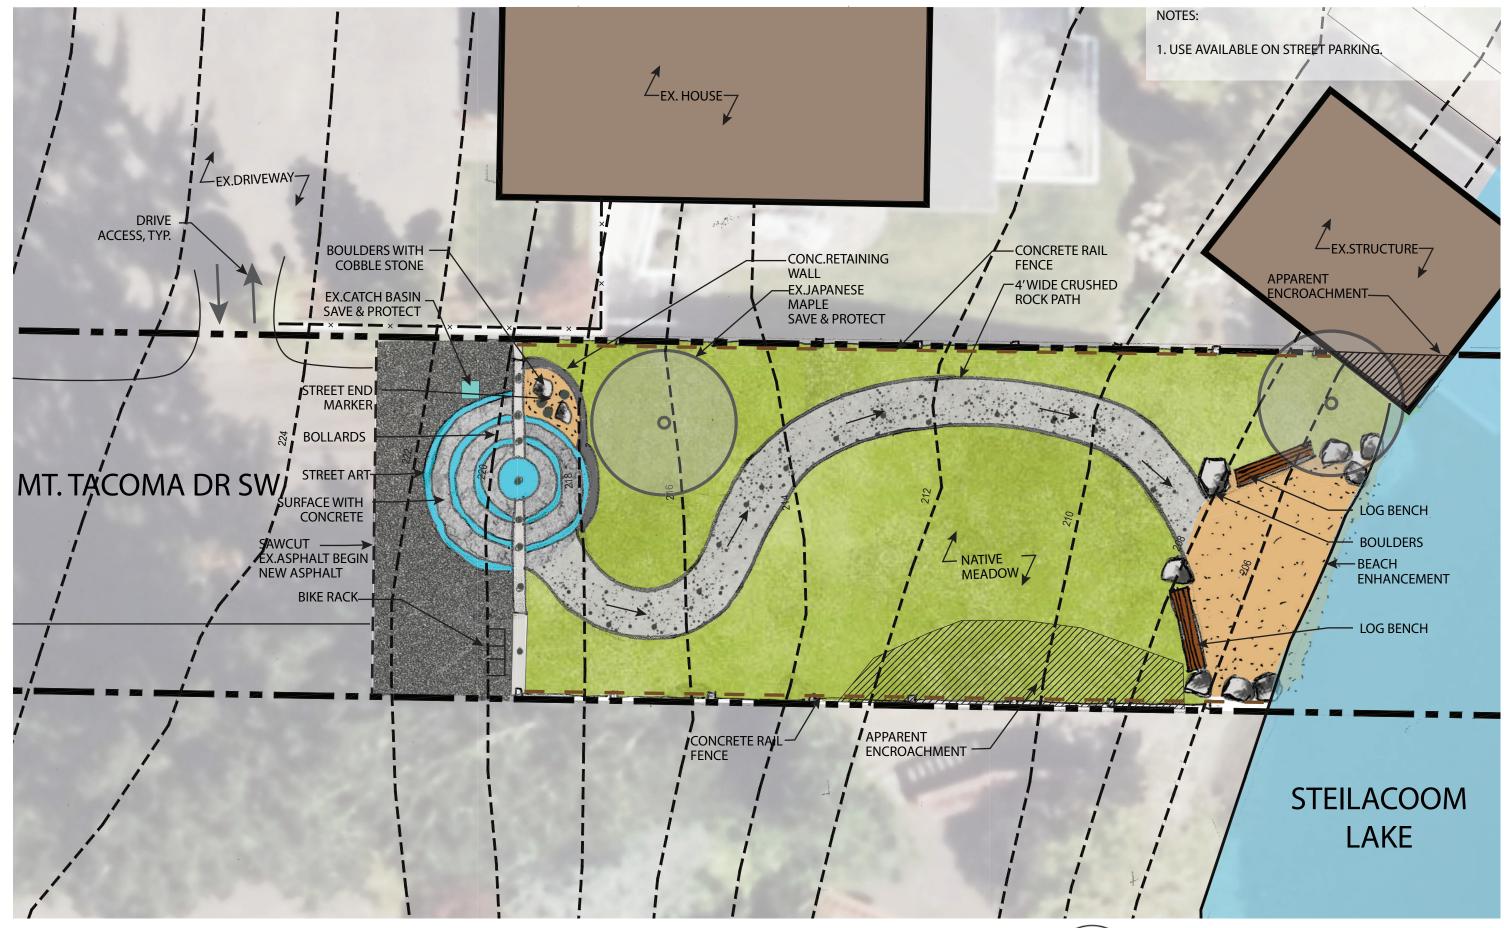
# 2 MT TACOMA DR SW - STEILACOOM LAKE

- 4. Traffic-rated bollards are proposed to replace the existing guardrail and open the site lines to the street end space
- 5. Painted street art at the entry to highlight the entry to the public space

- 10. Preserve existing Japanese maple
- 11. Landscape improvements include invasive removal and native plant restoration at the site's edges. The plant palette will be limited to low-growing shrubs such as sword fern, salal and snowberry.

- 12. Apparent encroachment is managed with a fence. A survey is needed to verify ROW and property boundaries.

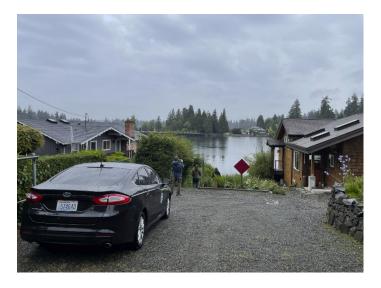
Open sight lines to the lake from the street and adjacent properties make the site feel safe.

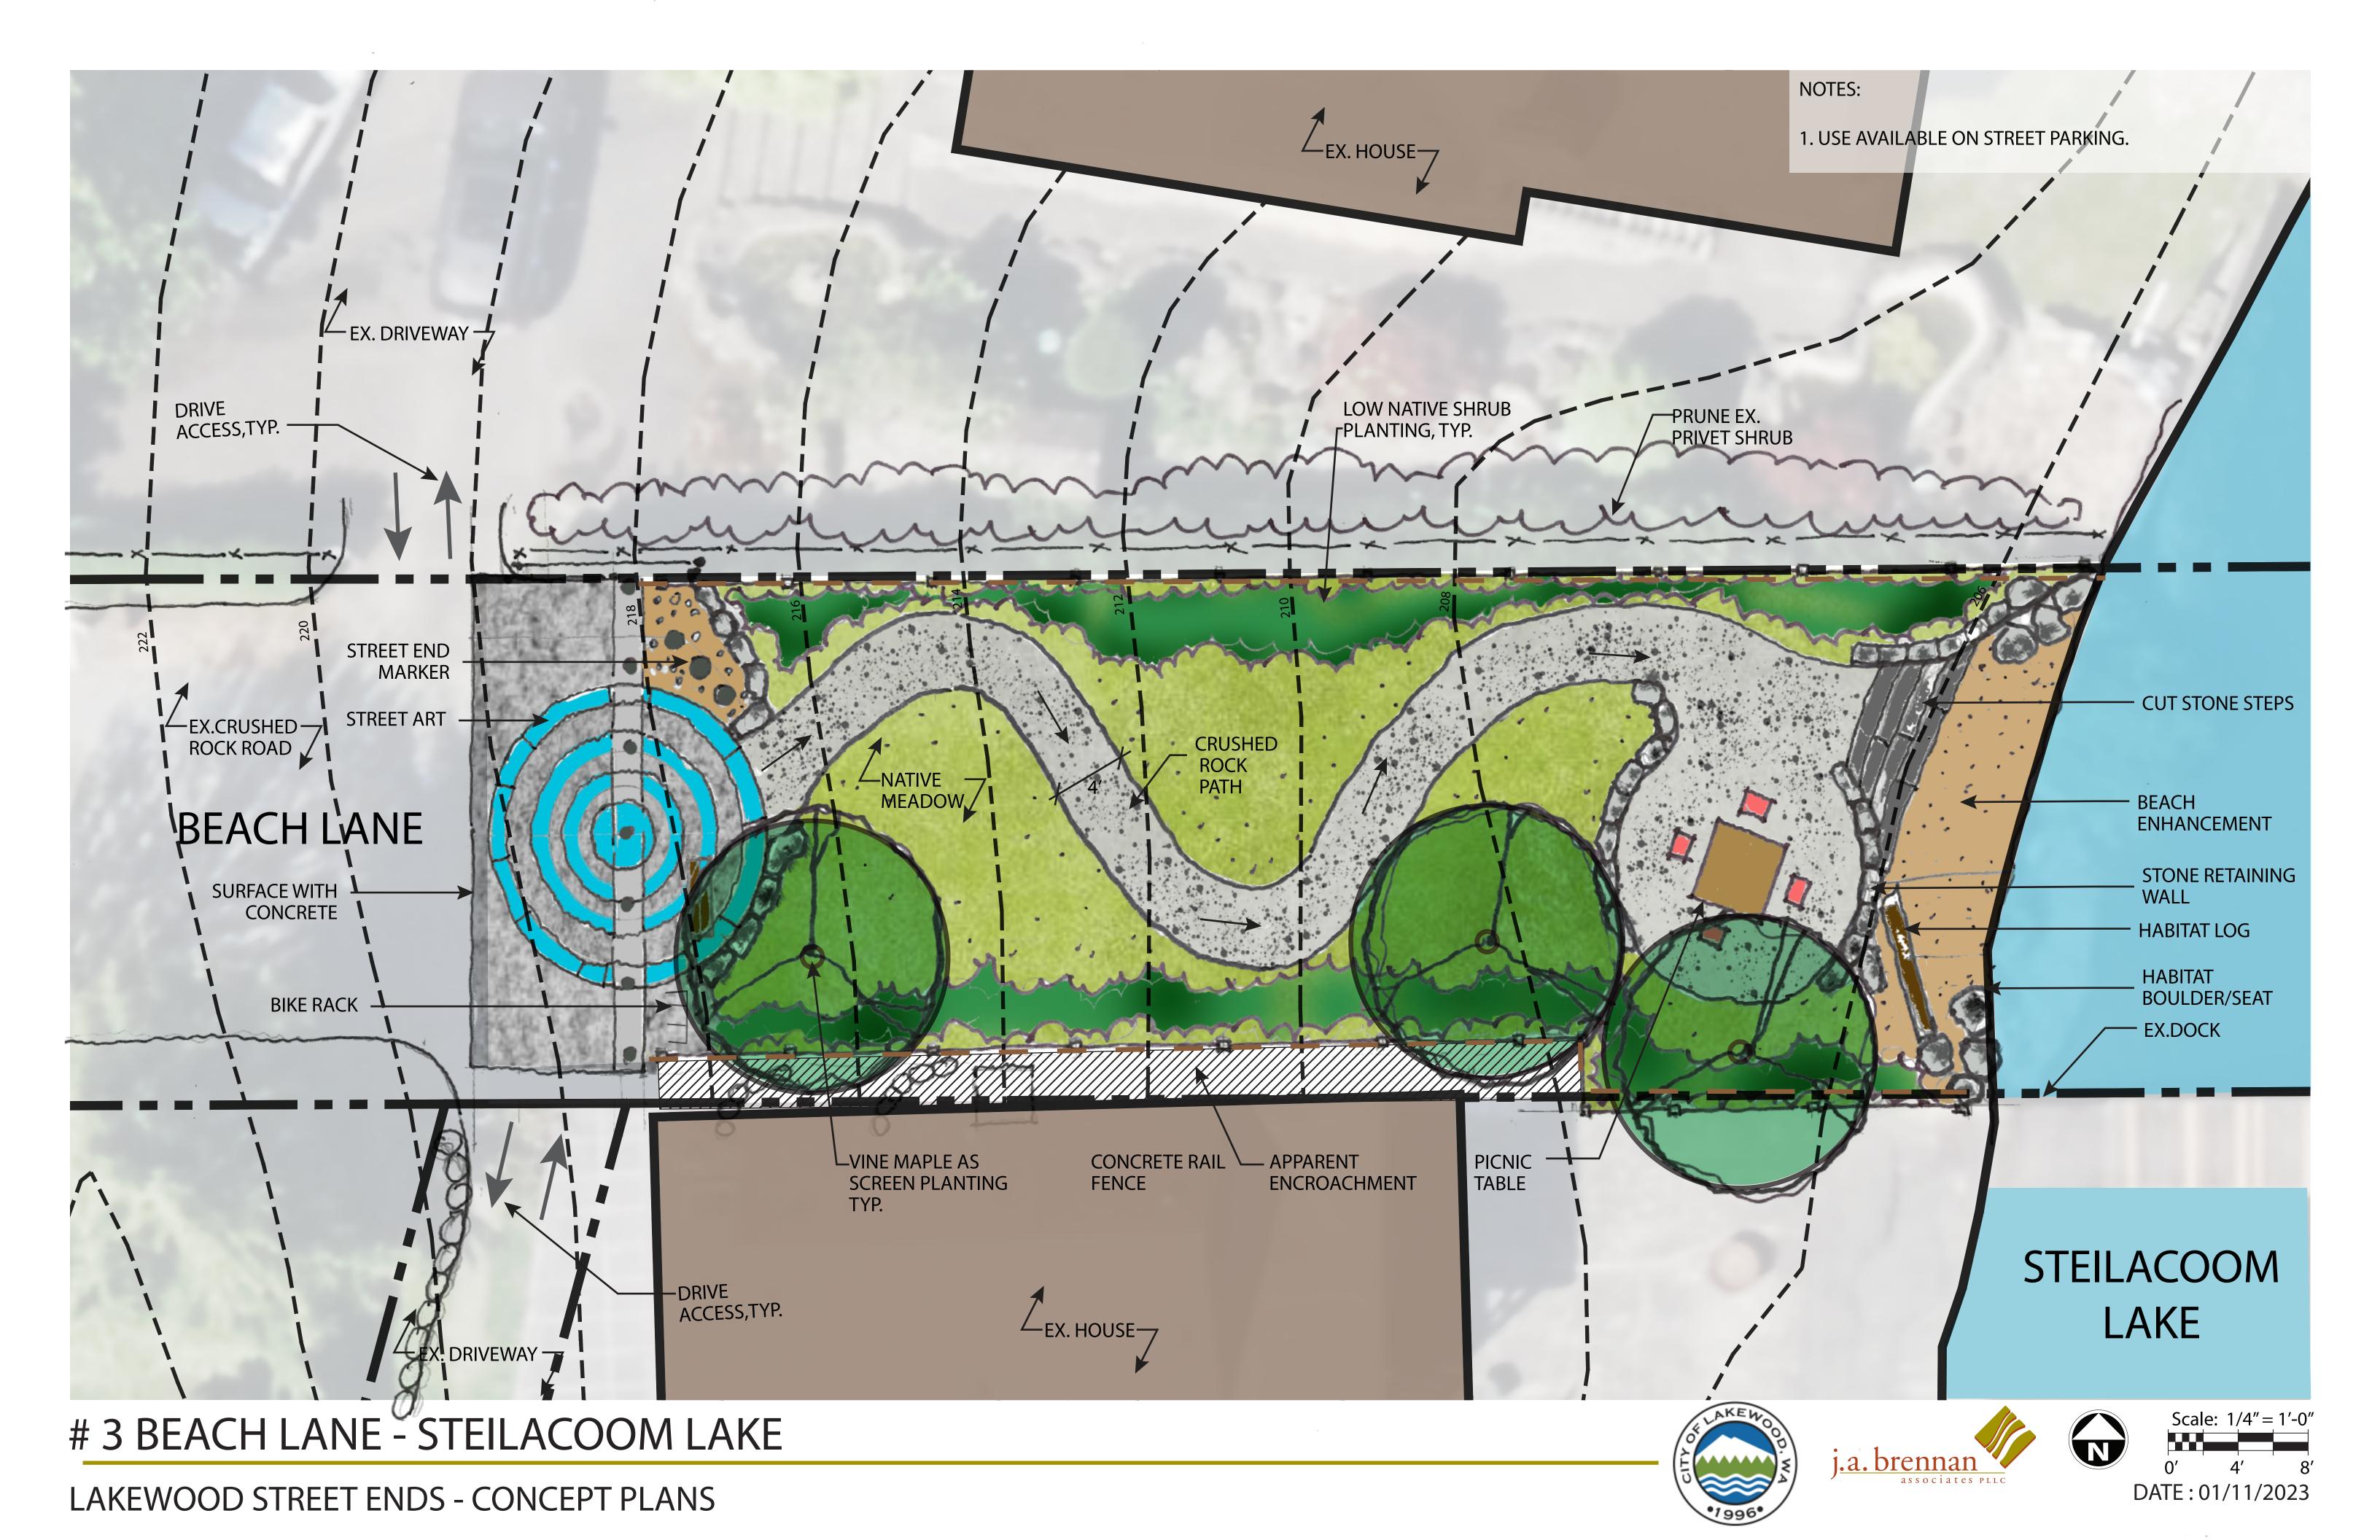
- 3. The street end marker is off-set from the street center line to ensure that site lines to the lake are maintained
- 4. Traffic-rated bollards are proposed to replace the existing curb and open the site lines to the street end space

- 12. Apparent encroachment is managed with a fence to screen the neighbors and protect the neighbors' utilities. A survey is needed to verify ROW and property boundaries.

- 13. Privet shrub on the property to the north will need to be pruned to reduce overhang into the ROW.

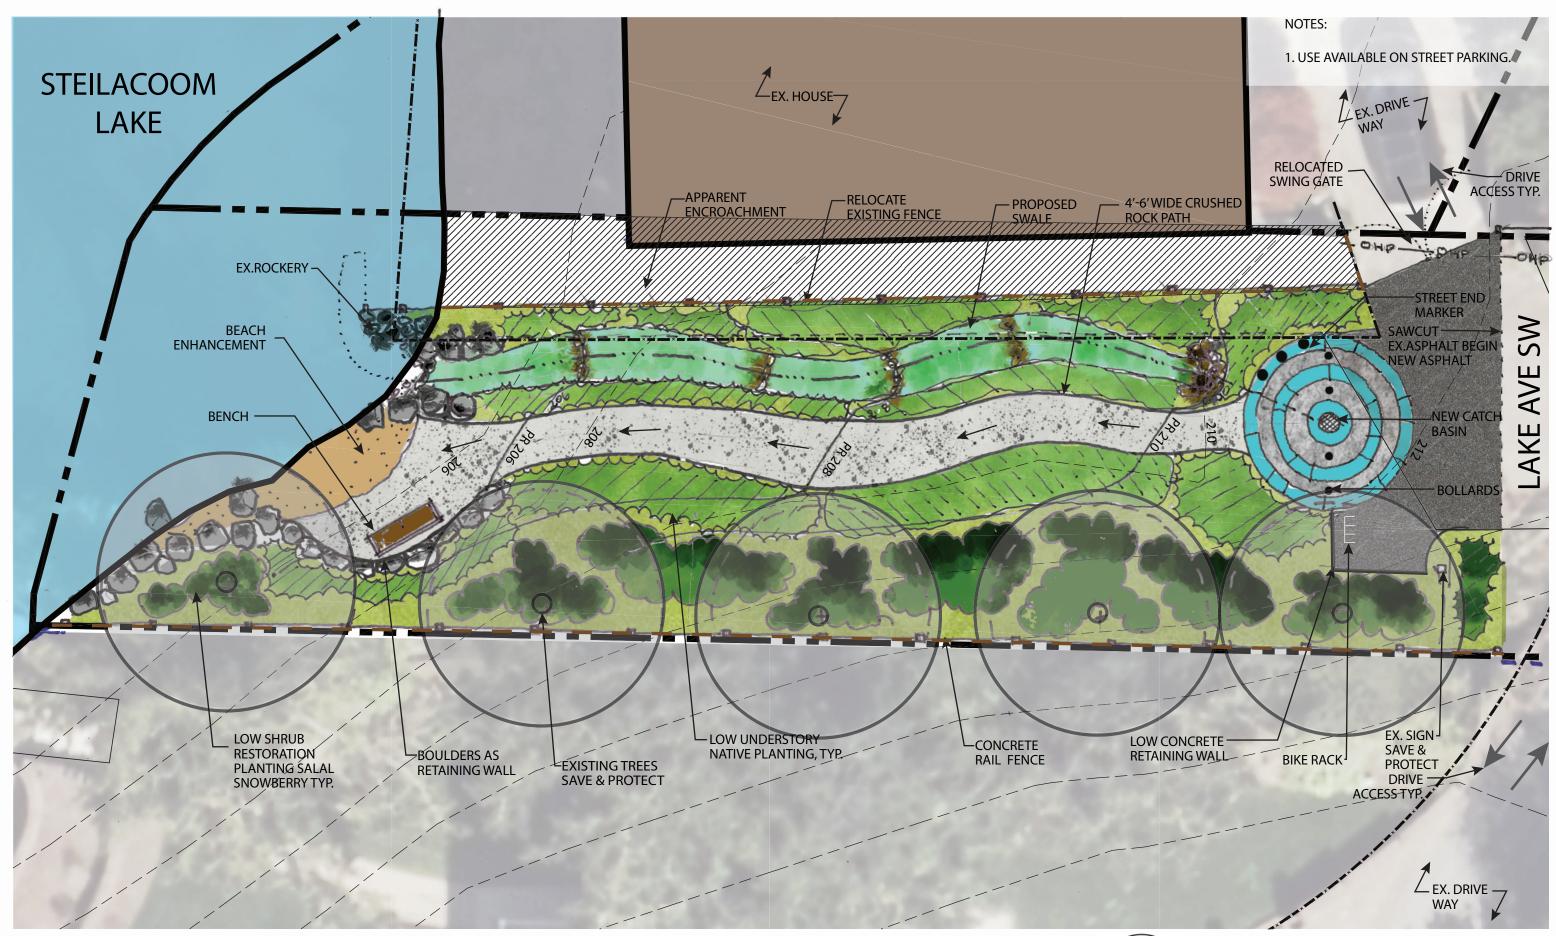
# 4 LAKE AVE SW - STEILACOOM LAKE

- 1. Maintain existing available parking in ROW.
- 2. New asphalt paved area is proposed to replace failing asphalt and enhance the entry sequence to the site.

- 5. The street end marker is centrally located to align with the street's center line, creating a visual connection to the site.
- 6. Traffic-rated bollards are proposed to replace the existing guardrail and open the site lines.

- 12. From the bench, the space connects the lake edge with an enhanced beach
- 13. Beach enhancements include adding a blended rounded gravel rock mix of 1" diameter to pea gravel-sized material placed above OHW. Habitat boulders are proposed as informal seating elements and beach features.

- 14. Landscape improvements include invasive removal and native plant restoration at the site's edges. The plant palette will be limited to low-growing shrubs such as sword fern, salal and snowberry.

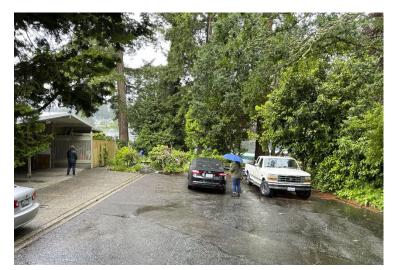
The property to the north has an ornamental garden and garden features in the ROW. The existing carport on the southern residence appears to be in the ROW. A formal survey to verify the extent of encroachment is required.

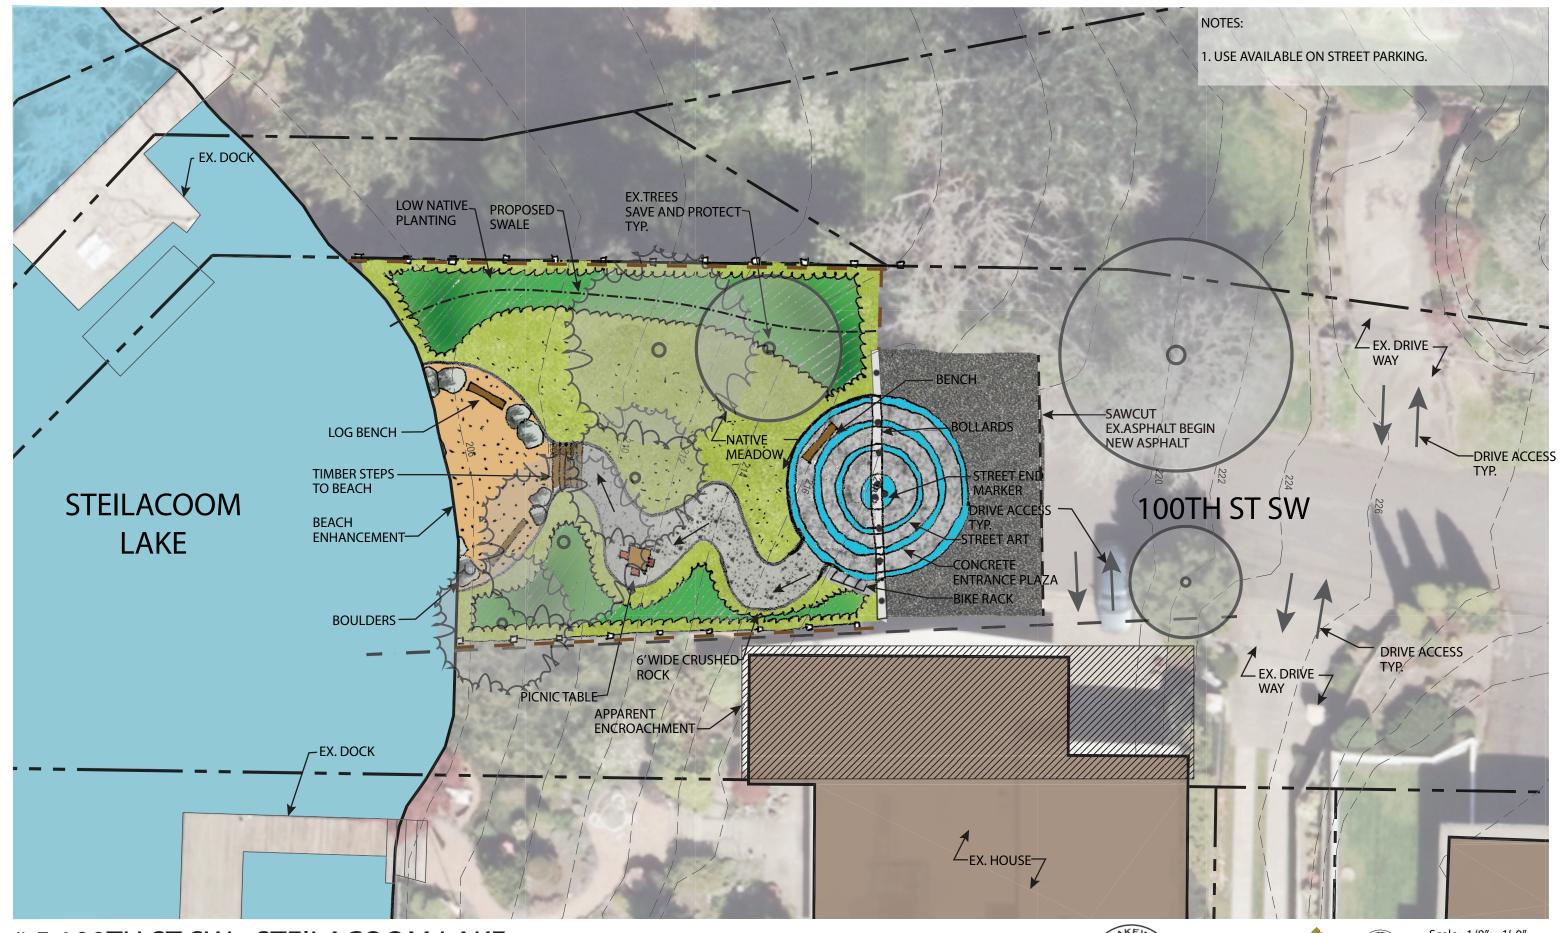
# 5 100TH ST SW - STEILACOOM LAKE

- 1. Maintain existing available parking in ROW.
- 2. New asphalt paved area is proposed to replace failing asphalt and enhance the entry sequence to the site.

- 5. The street end marker is centrally located to align with the street's center line, creating a visual connection to the site.
- 6. Traffic-rated bollards are proposed to replace the existing guardrail and open the site lines.

- 12. From the steps, the space connects the lake edge with an enhanced beach
- 13. Beach enhancements include adding a blended rounded gravel rock mix of 1" diameter to pea gravel-sized material placed above OHW. Habitat boulders are proposed as informal seating elements and beach features.

- 14. Landscape improvements include invasive removal and native plant restoration at the site's edges. The plant palette will be limited to low-growing shrubs such as sword fern, salal and snowberry.

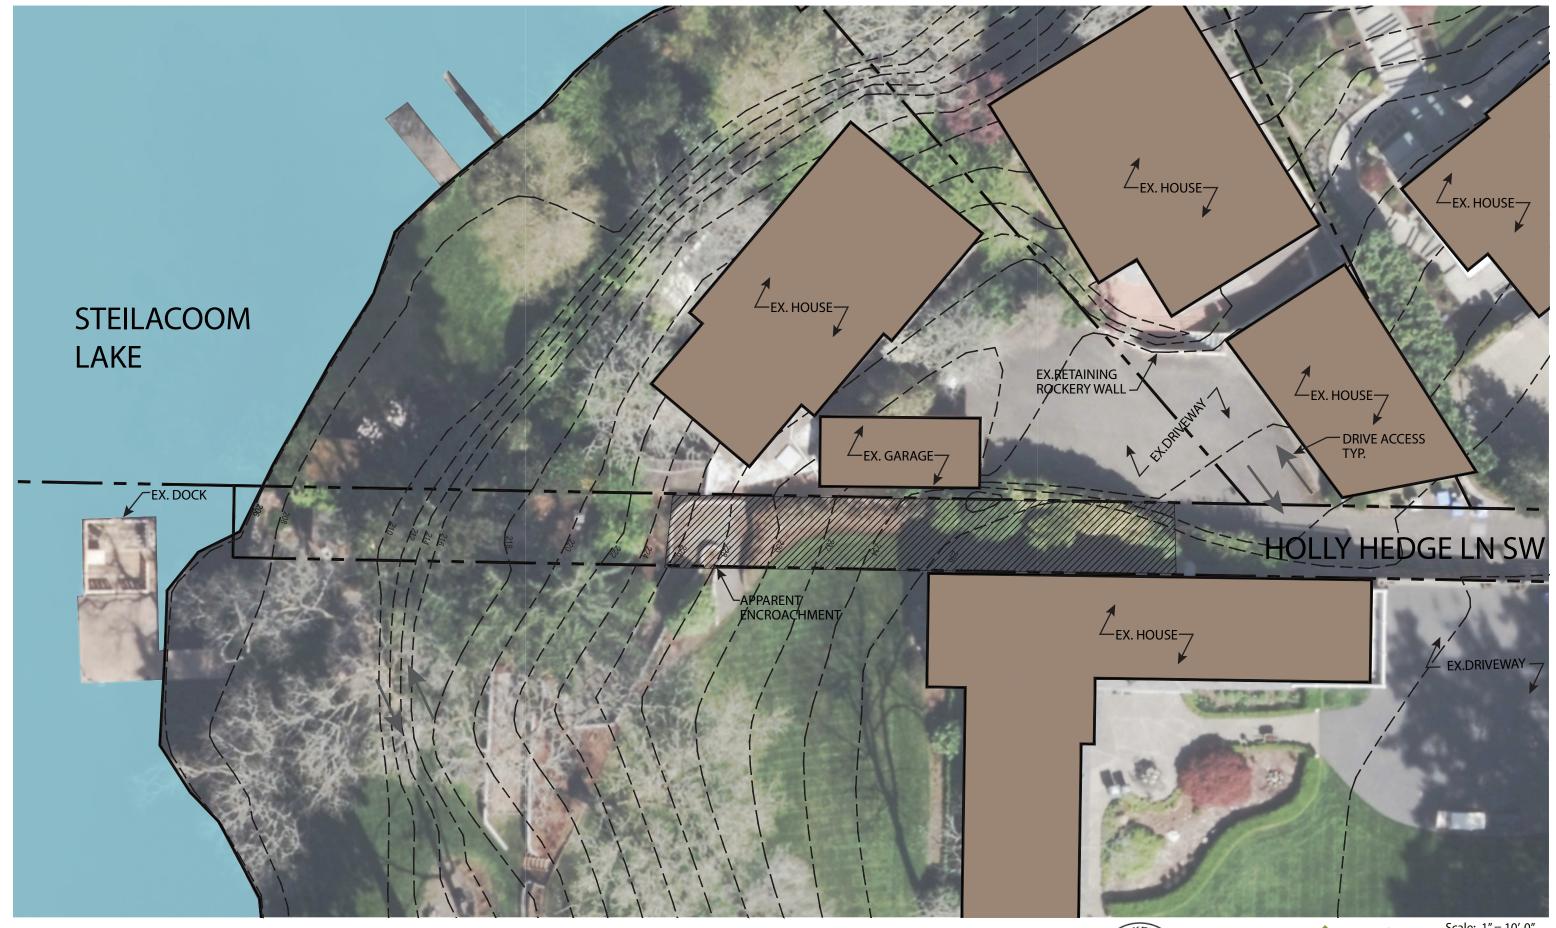
# 6 HOLLY HEDGE LN SW - STEILACOOM LAKE (NO DEVELOPMENT)

# Proposed improvements include:

None proposed

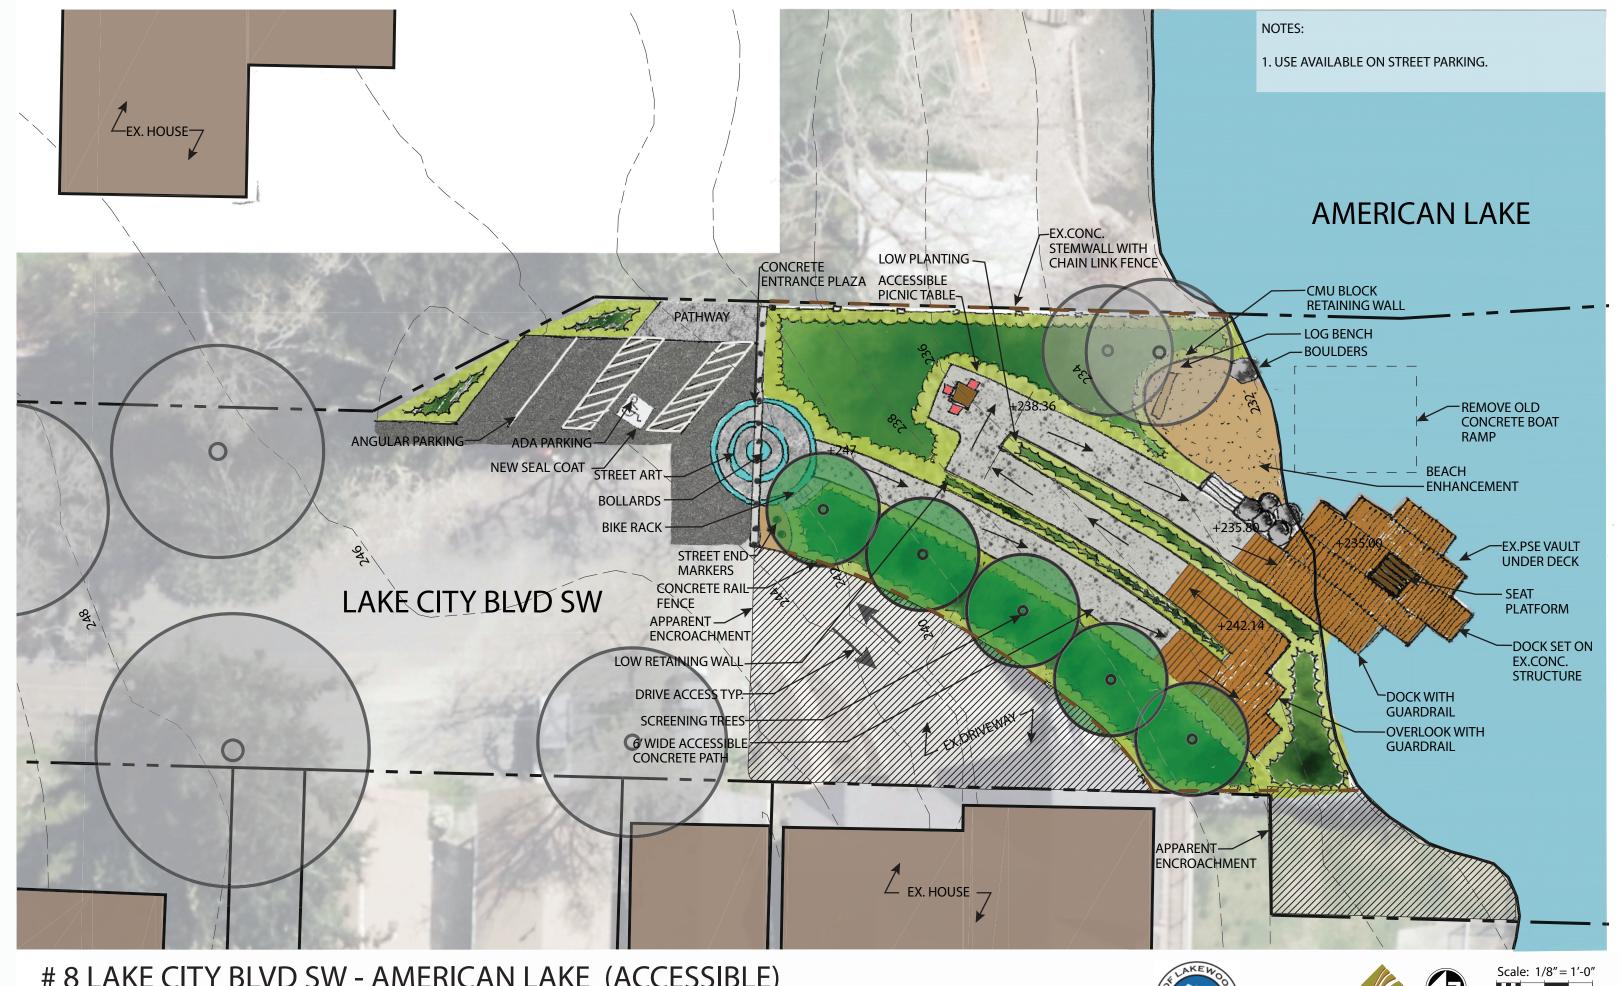
# 8 LAKE CITY BLVD SW - AMERICAN LAKE (ACCESSIBLE)

- 3. The street end marker is located at the southeast edge to align with the center line of the street, creating a visual connection to the site.
- 4. Traffic-rated bollards are proposed to replace the northern guardrail and open the site lines to the street end space.

- 5. Painted street art at the entry to highlight the entry to the public space.
- 6. Replace the fence with a low concrete rail fence to open site lines.

- 7. To enhance the welcome feeling at the site a low shrub planting with a row of vine maples is proposed to define the park edge on the west side, allowing views into the park while providing a sense of privacy to the neighbors. The concrete rail fence replaces a 6' tall chain link fence and traffic guardrail with ivy.

- 13. Beach enhancements include the removal of debris from a broken concrete boat launch and the placement of a blended rounded gravel rock mix comprised of 1" diameter to pea gravel-sized material. Habitat boulders are proposed as informal seating elements and beach features.

- 14. Landscape improvements include a plant palette limited to low-growing shrubs such as sword fern, salal and snowberry with limited use of low-growing trees such as vine maple.

- 15. There is significant apparent encroachment on the south-westerly property area.

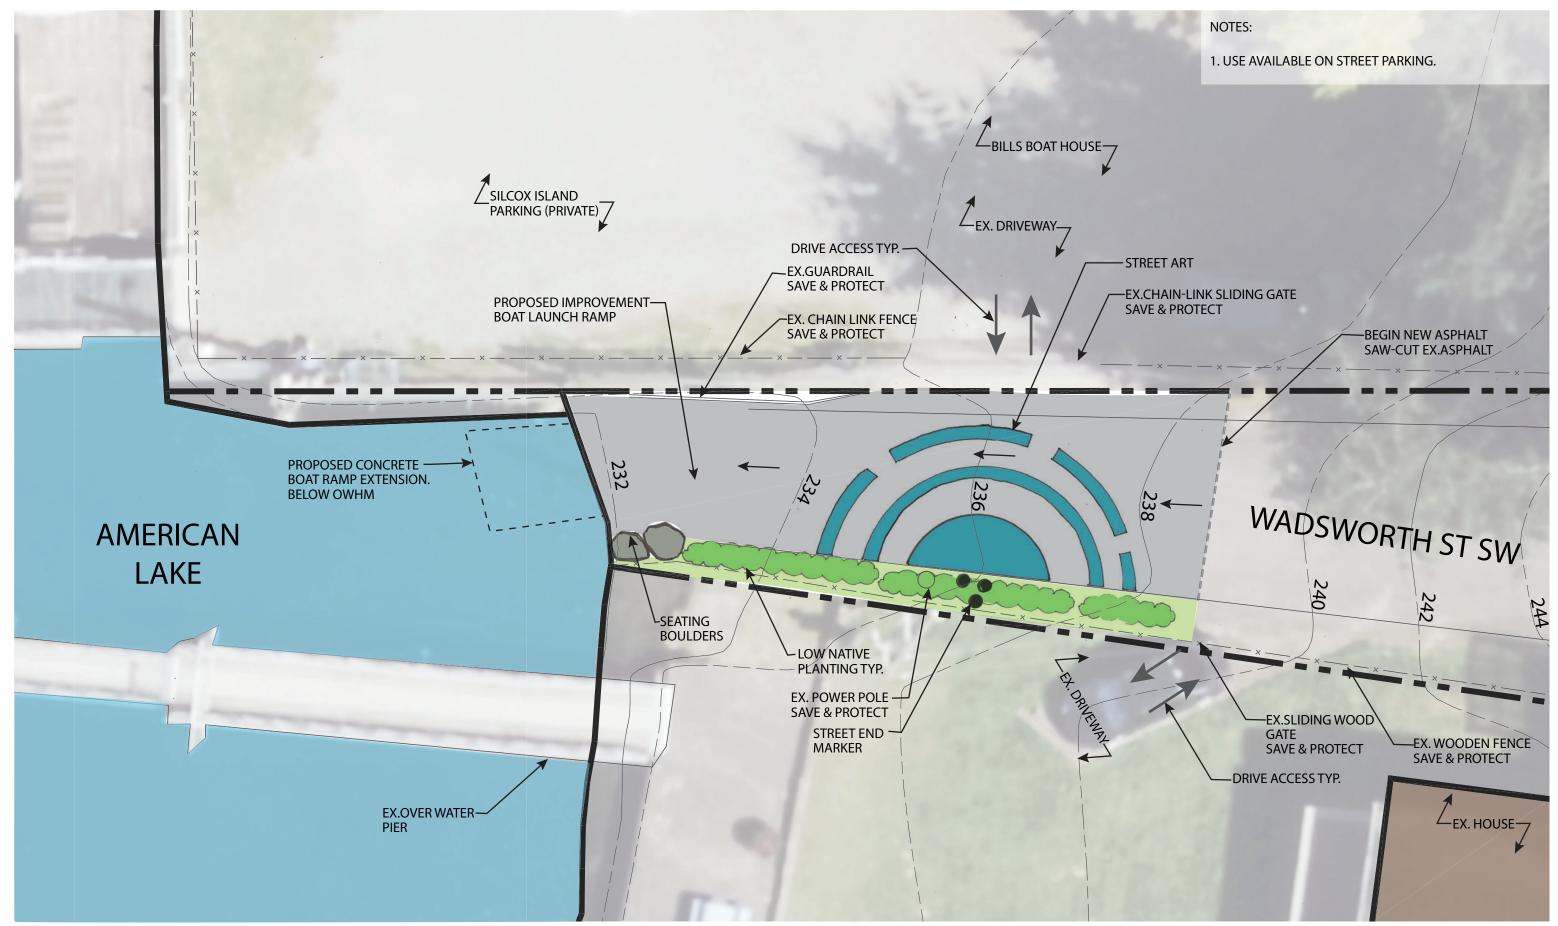
Consideration for improved boat launch amenities, pavement place making elements and access marker. Some modest plantings can also be considered.

- 1. Maintain existing available parking in ROW.
- 2. New concrete surfacing is proposed to improve the boat launch.
- 3. The street end marker is off set to maintain boat launch access.
- 4. Traffic-rated bollards are proposed to protect the marker.
- 5. Painted street art emerges from the marker creating a series of concentric arcs emanating from the marker.
- 6. Habitat boulders are proposed as informal seating elements and features at the shoreline edge.
- 7. Landscape improvements are limited to enhancing the narrow strip on the west side of the access. The plant palette will be limited to low-growing shrubs such as sword fern, salal and snowberry.

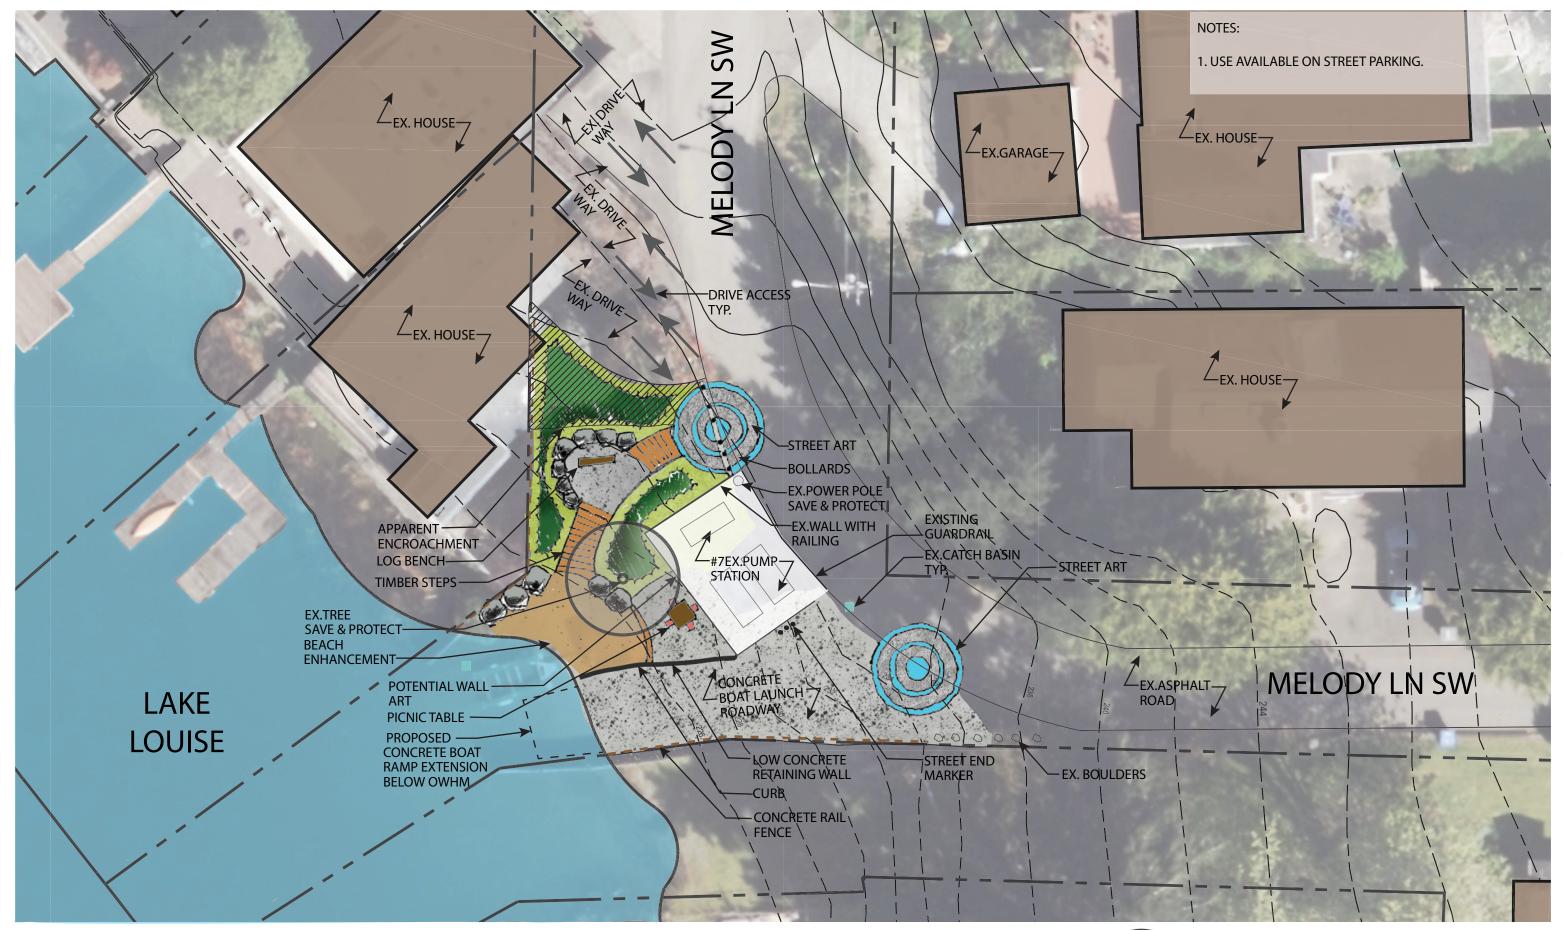
# 10 MELODY LN SW - LAKE LOUISE

- 9. Seating steps are proposed to connect the picnic space to the beach edge.
- 10. Beach enhancements include adding a blended rounded gravel rock mix of 1" diameter to pea gravel-sized material placed above OHW. Habitat boulders are proposed as informal seating and beach features; a log bench is provided for users.

- 11. Landscape improvements include invasive removal and native plant restoration at the north edge of the site. The plant palette will be limited to low-growing shrubs such as sword fern, salal and snowberry.

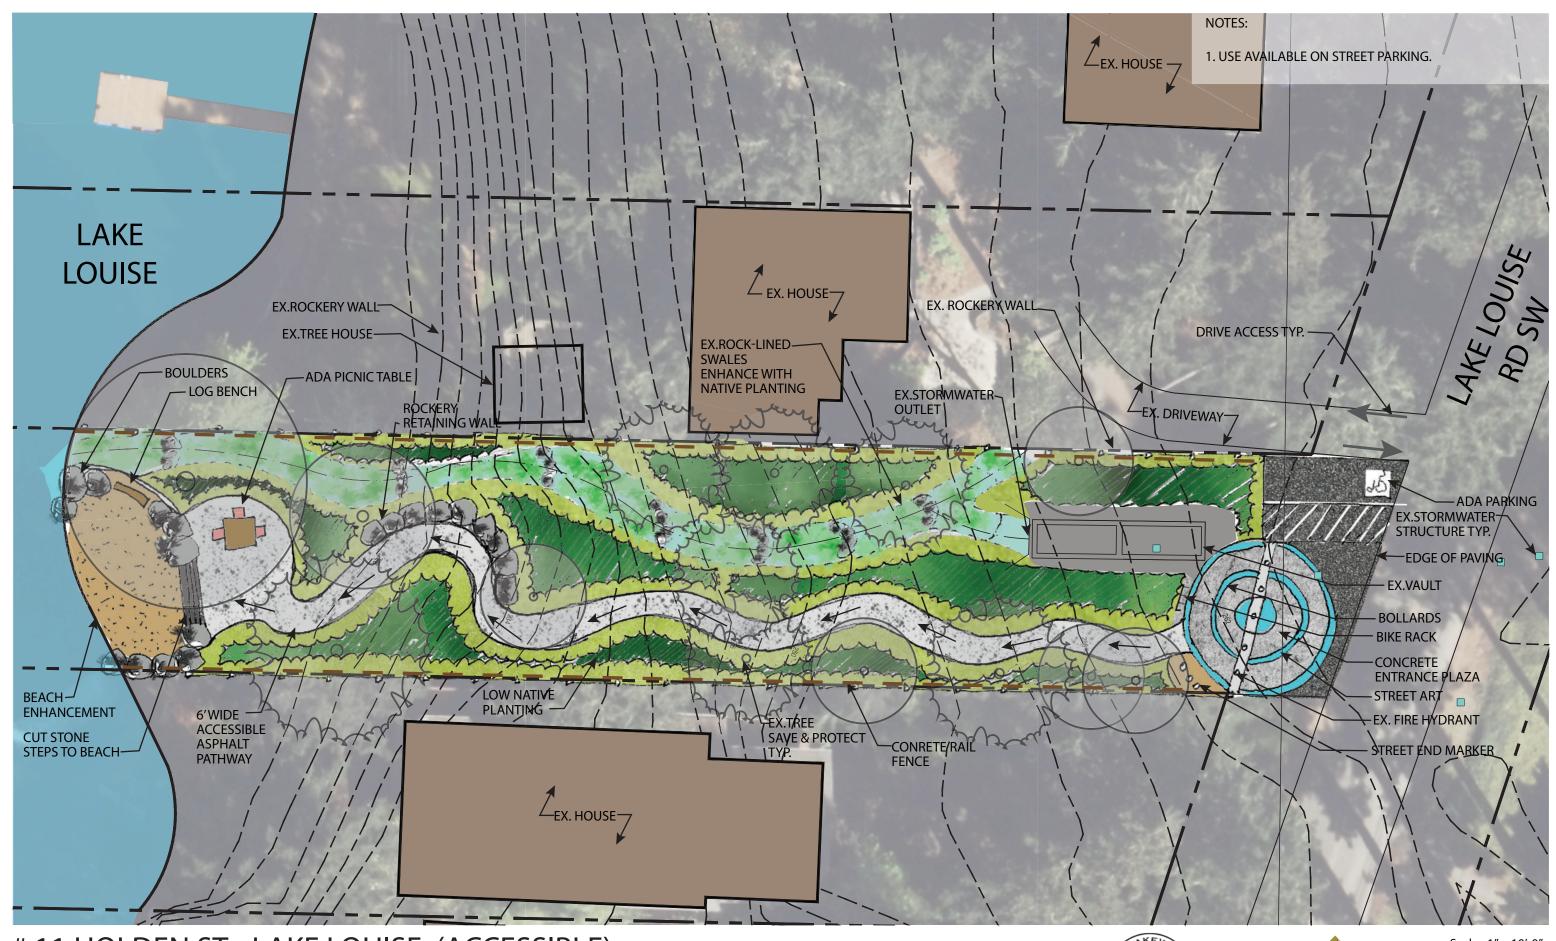
# 11 HOLDEN ST - LAKE LOUISE (ACCESSIBLE)

- 5. The street end marker is centrally in the entry plaza creating a visual connection to the site
- 6. Traffic-rated bollards are proposed to replace the existing bollards

- 12. Beach enhancements include adding a blended rounded gravel rock mix of 1" diameter to pea gravel-sized material placed above OHW. In some areas the existing sand beach should be retained. Habitat boulders are proposed as informal seating elements and beach features.

- 13. Landscape improvements include invasive removal and native plant restoration at the site's edges. The plant palette will be limited to low-growing shrubs such as sword fern, salal and snowberry.

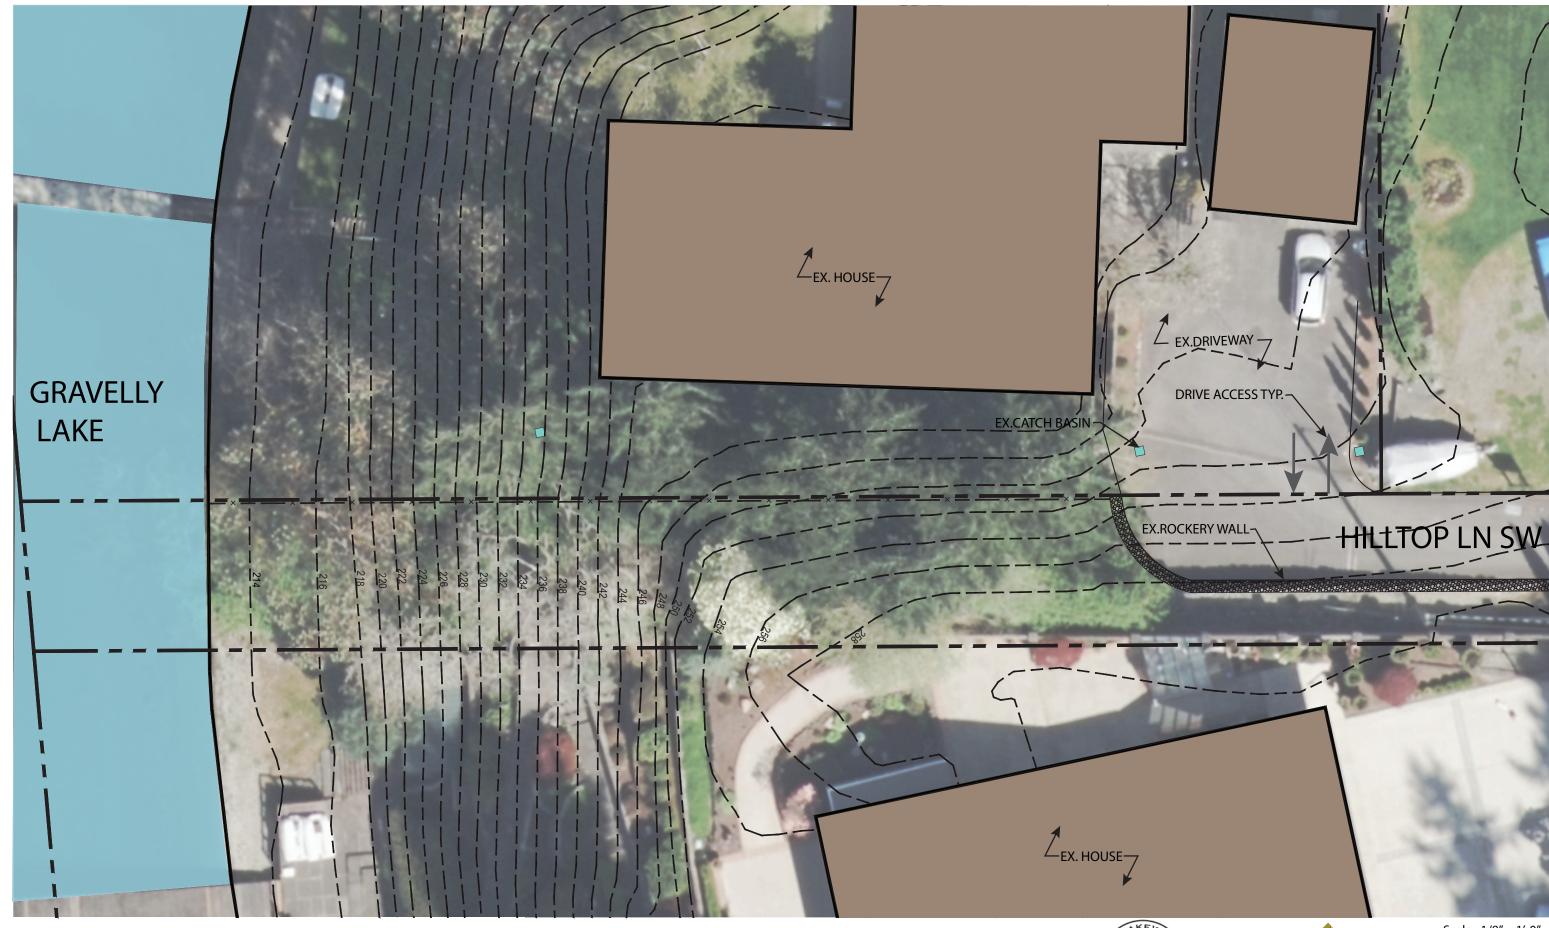
# 12 HILLTOP LN SW - GRAVELLY LAKE (NO DEVELOPMENT)

### Proposed improvements include:

Future investigation including vegetation clearing and a site survey could further verify potential for development. Due to access limitations noted above, no development is proposed for this assessment.

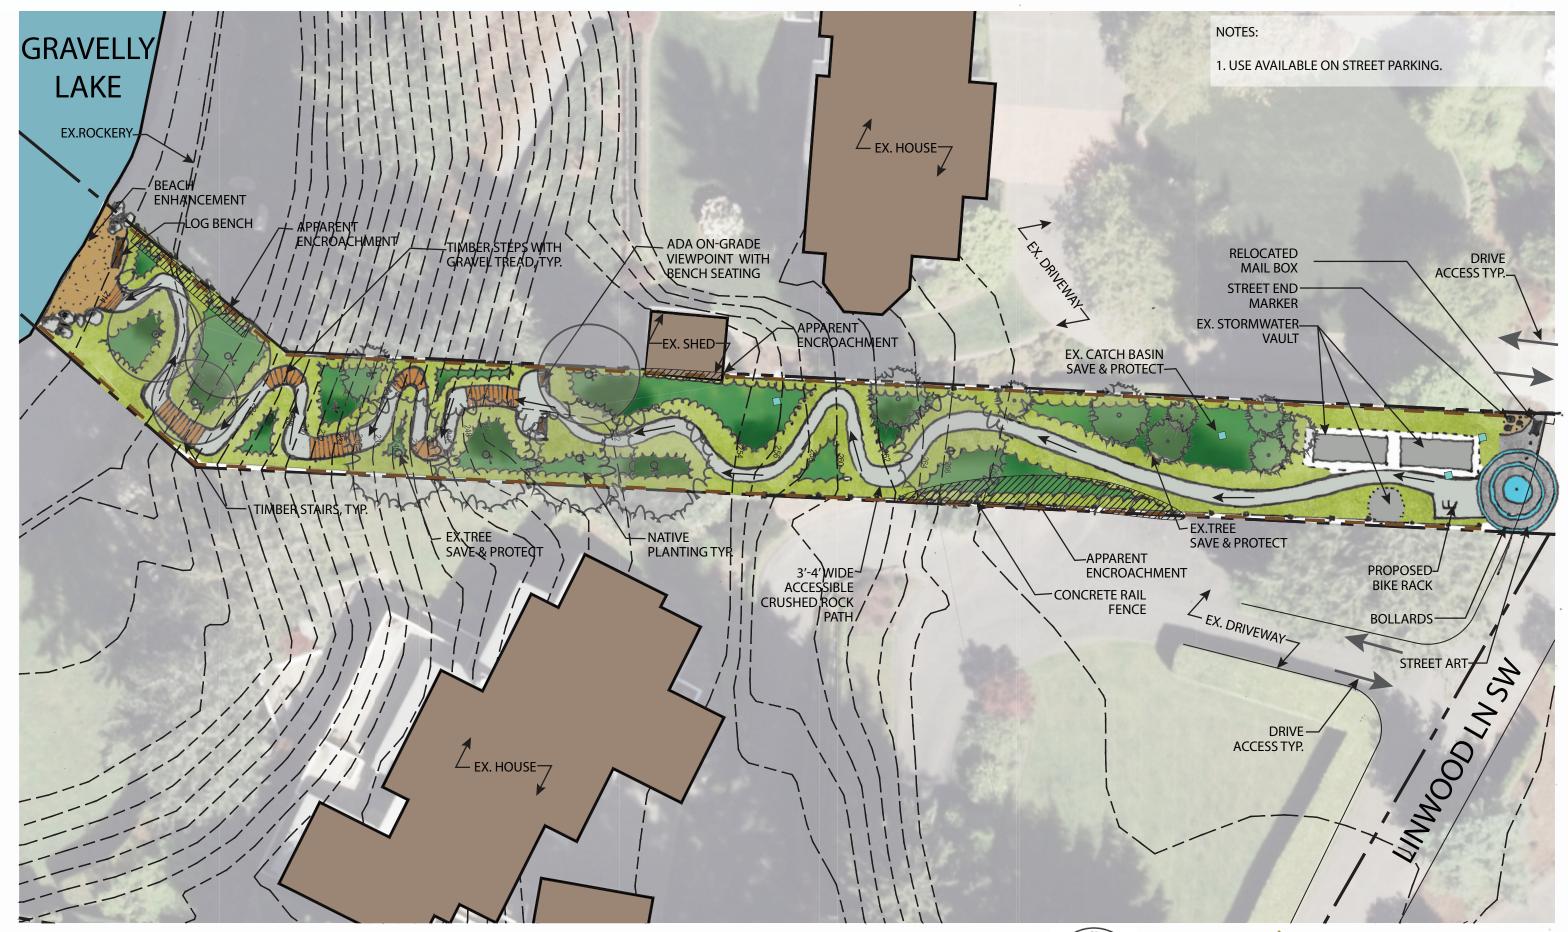
# 13 LINWOOD LN SW - GRAVELLY LAKE (ACCESSIBLE)

- 3. The street end marker is located at this NW edge to align with the street's center line, creating a visual connection to the site.
- 4. Traffic-rated bollards are proposed to replace the wooden gate and fence and open the site lines to the street end space.

- 9. Beach enhancements include adding a blended rounded gravel rock mix of 1" diameter to pea gravel-sized material above OHW. Habitat boulders are proposed as informal seating elements and beach features, a small habitat log placed at the beach edge is also included.

- 10. Landscape improvements include invasive removal on the slope and native plant restoration. The plant palette will be limited to low-growing shrubs such as sword fern, salal and snowberry.
