Lake Steilacoom Bridge Repair Update

City of
Lakewood

Current Bridge Condition Summary

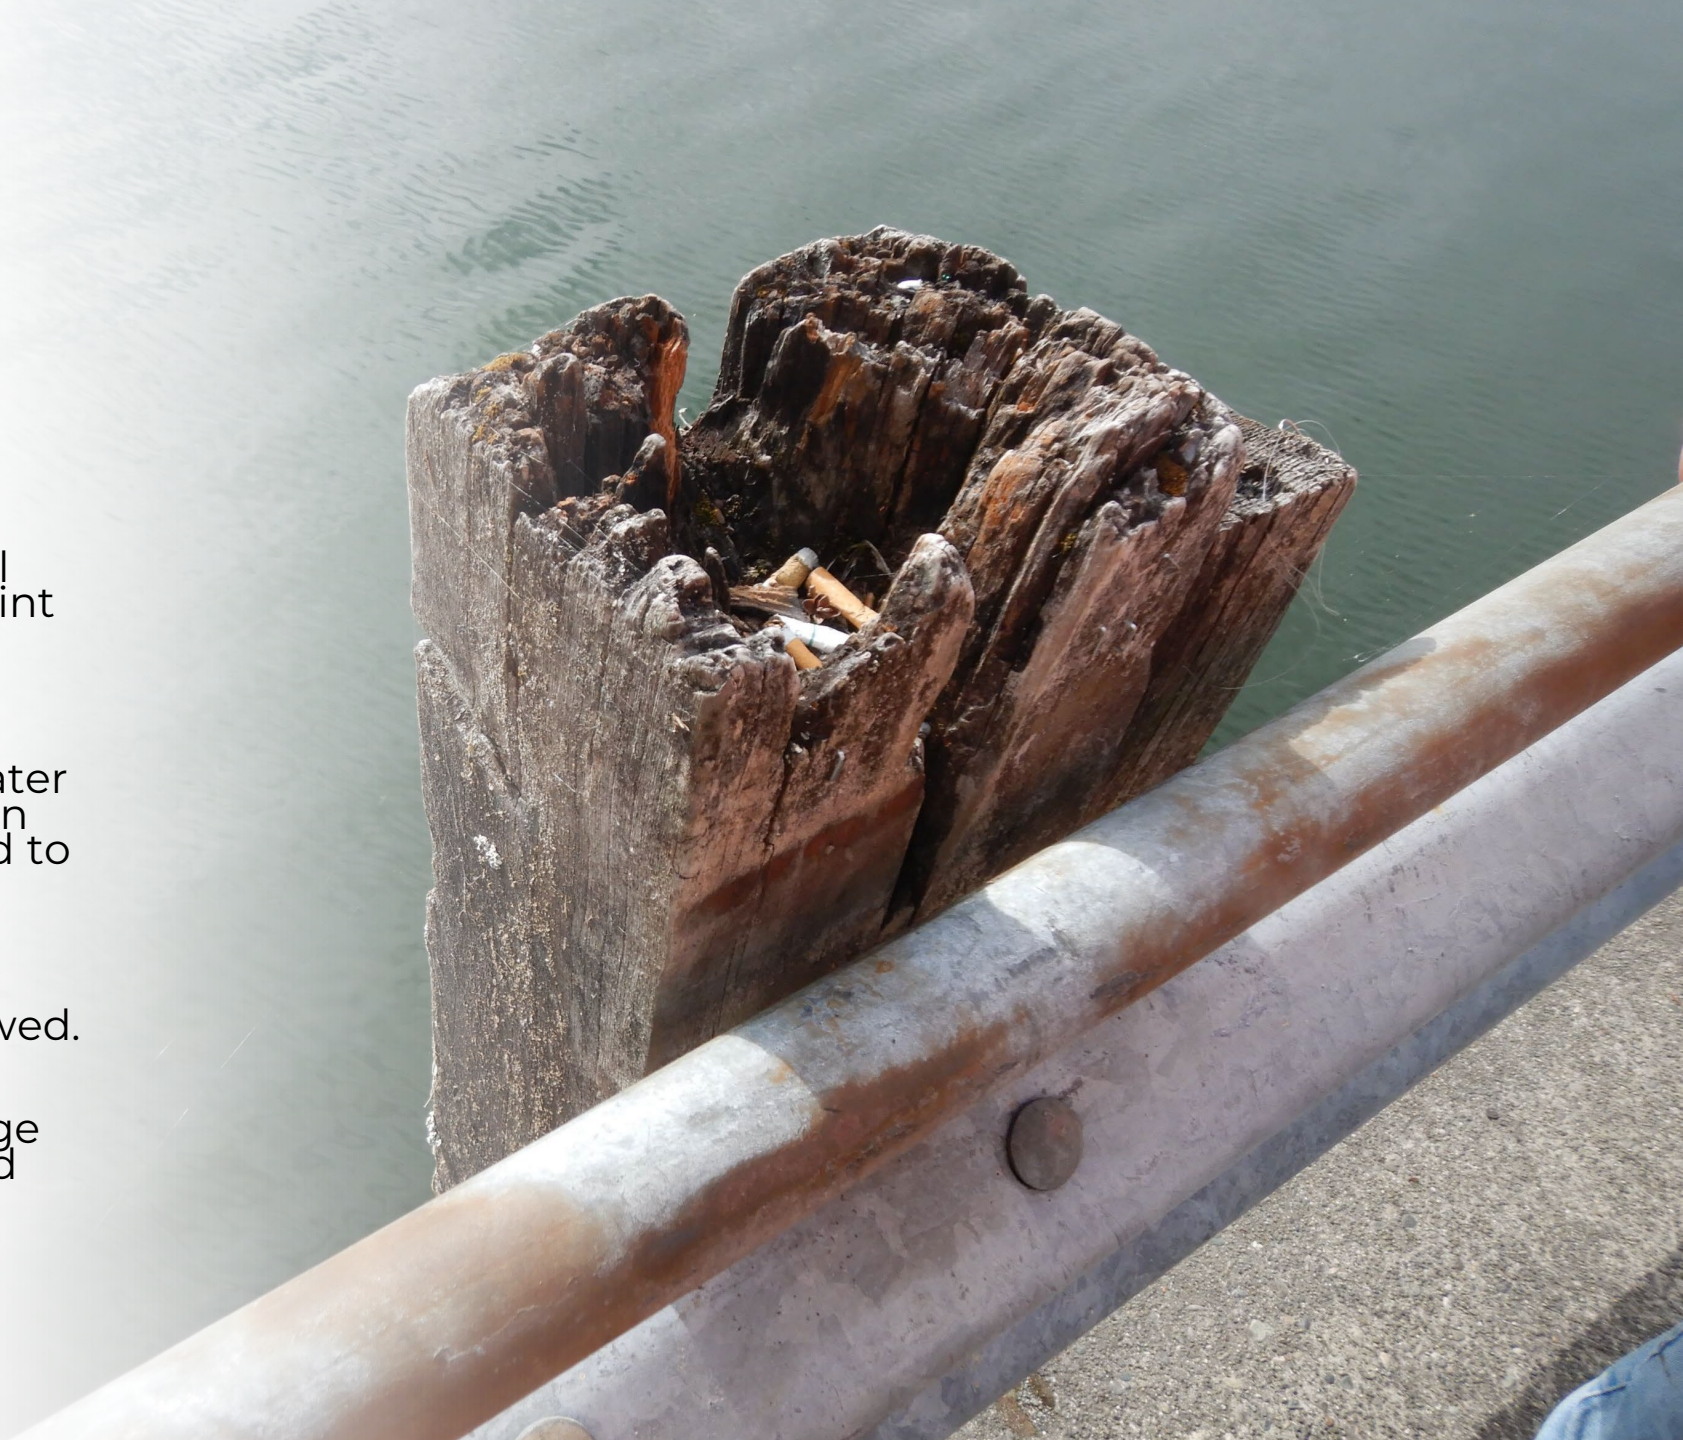
- The rail posts have show significant deterioration and will need to be replaced at some point in the future.
- Additionally, seven piles have issues above and right at the water level. Options will be evaluated in the coming years and presented to Council for further discussion.
- Timber braces are starting to wear and may need to be reviewed.
- Continue to monitor the bridge every two years above water and five years below water
