Appendix E Geotechnical Report

GEOTECHNICAL REPORT JBLM – NORTH ACCESS IMPROVEMENT PROJECT Washington Boulevard Southwest and Gravelly Lake Drive Southwest Lakewood, Washington

PROJECT NO. 20-024 June 2020

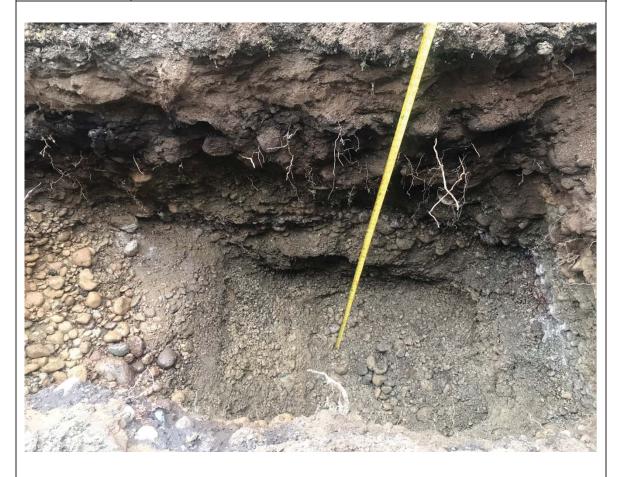
Test Pit PIT-1 Location: 47.14863, -122.56243 (See Figure 2) Approximate ground surface elevation: 238 feet (Based on Google Earth)				
Depth (ft)	Material Description			
0 - 1/4	Medium dense, grey, fine gravelly coarse SAND; moist; poorly graded, angular gravel, crushed rock (Fill)			
$\frac{1}{4} - \frac{1}{2}$	Loose, brown, silty fine SAND; moist; poorly graded (Fill)			
1/2 – 2	Loose, dark brown, slightly organic, sandy, gravelly SILT; moist; poorly graded, non-plastic (Old Topsoil/Fill) • Grades to sandy gravel			
2-6	Loose, grey-brown, slightly sandy to sandy GRAVEL; moist; poorly graded (Steilacoom Gravel)

Test Pit 1 (PIT-1) was initially terminated approximately 4 feet below grade for infiltration testing. After the test, PIT-1 was over excavated to check for high groundwater or immediate groundwater mounding.

No groundwater seepage or mounding was observed during the excavations. PIT-1 terminated approximately 6 feet below ground surface in caving conditions.

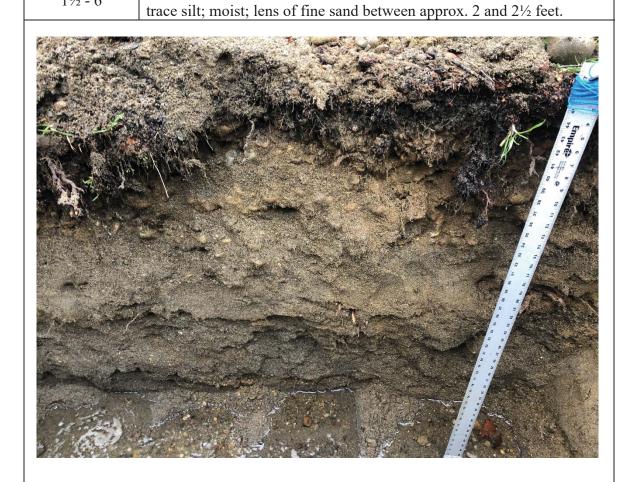
Test Pit PIT-2				
Location: 47.14	5818, -122.560086 (See Figure 2)				
Approximate gro	ound surface elevation: 261 feet (Based on Google Earth)				
Depth (ft)	Material Description				
$0 - \frac{1}{2}$	Grass and sod over loose, brown to dark brown, silty fine to medium				
$0 - \frac{7}{2}$	SAND, trace gravel, trace organic material (rootlets); moist; (Fill)				
1/2 - 11/2	Loose, light brown, fine to medium SAND with gravel, trace silt, trace				
	organic debris (rootlets); moist; (Steilacoom Gravel)				
1½ - 6	Loose to medium dense, light brown to brown, fine to medium SAND,				
	. 11. 1. 1. 0.00 11.

Test Pit 2 (PIT-2) was initially terminated approximately 4 feet below grade for infiltration testing. After the test, PIT-2 was over excavated to check for high groundwater or immediate groundwater mounding.

No groundwater seepage or mounding was observed during the excavations. PIT-2 terminated approximately 6 feet below ground surface in caving conditions.

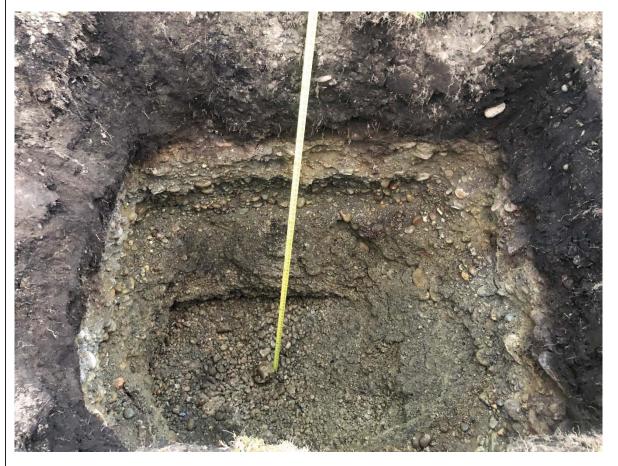
Location: 47.148650, -122.551497 (See Figure 2)

Depth (ft)	Material Description
$0-1\frac{1}{2}$	Grass and sod over loose, dark brown, silty fine to medium SAND, trace gravel, trace organic material (rootlets); moist; (Fill)
1½ – 7	Loose to medium dense, brown, fine to medium sandy GRAVEL (subrounded, poorly graded) to gravelly fine to medium SAND; moist; unit becomes less weathered with depth (Steilacoom Gravel)

Test Pit 3 (PIT-3) was initially terminated approximately 4 feet below grade for infiltration testing. After the test, PIT-3 was over excavated to check for high groundwater or immediate groundwater mounding.

No groundwater seepage or mounding was observed during the excavations. PIT-3 terminated approximately 7 feet below ground surface in caving conditions.

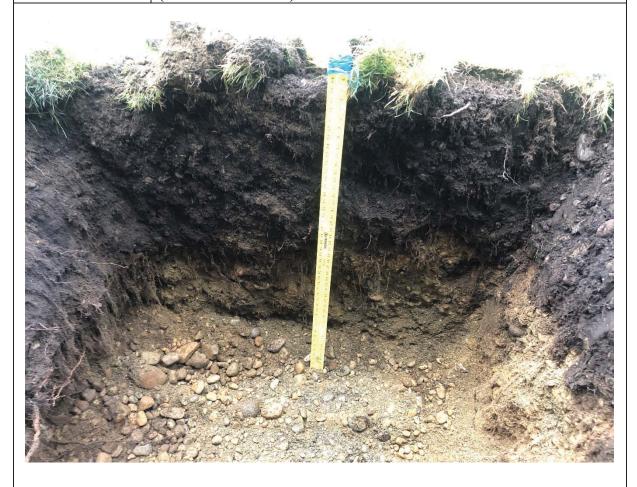
Test Pit PIT-4 Location: 47.14867, -122.54450 (See Figure 2) Approximate ground surface elevation: 262 feet (Based on Google Earth) Depth (ft) O-2 Grass and sod over loose, dark brown, slightly organic, slightly silty, sandy GRAVEL; moist; poorly graded, rootlets (Fill) Loose, grey-brown, slightly sandy GRAVEL; moist; poorly graded (Steilacoom Gravel)

Test Pit 4 (PIT-4) was initially terminated approximately 4 feet below grade for infiltration testing. After the test, PIT-4 was over excavated to check for high groundwater or immediate groundwater mounding.

No groundwater seepage or mounding was observed during the excavations. PIT-4 terminated approximately 7 feet below ground surface in caving conditions.

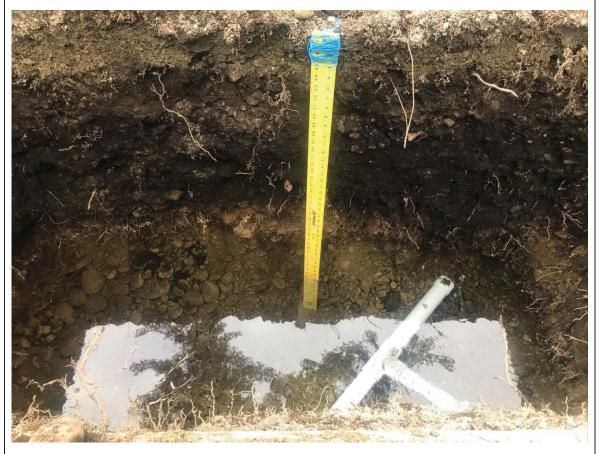
Location: 47.14335, -122.53765 (See Figure 2)

Test Pit 5 (PIT-5) was initially terminated approximately 4 feet below grade for infiltration testing. After the test, PIT-5 was over excavated to check for high groundwater or immediate groundwater mounding.

No groundwater seepage or mounding was observed during the excavations. PIT-5 terminated approximately 6 feet below ground surface in caving conditions.

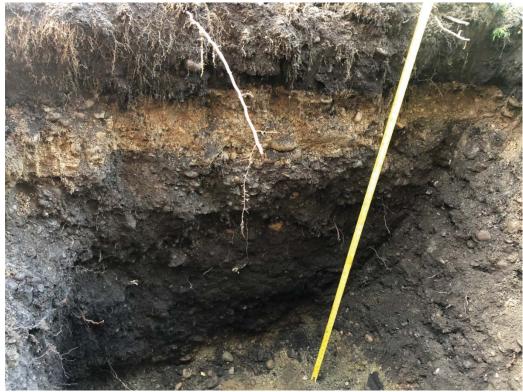
Test Pit PIT-6 Location: 47.141247, -122.526488 (See Figure 2) Approximate ground surface elevation: 278 feet (Based on Google Earth)

Depth (ft)	Material Description
0 – 1	Grass and sod over loose, dark brown, silty fine to medium SAND,
1 – 2	trace gravel, trace organic material (rootlets); moist; (Fill) Loose, brown to orange, fine to medium SAND with gravel, trace silt;
2 – 4	moist; appears to be reworked native material Loose, dark brown, silty fine to medium SAND, trace to some gravel,
2 .	trace organic material (rootlets); moist.(Old Topsoil/Fill) Loose to medium dense, light brown to brown, fine to medium sandy
$4-6^{3}/_{4}$	GRAVEL (sub-rounded, poorly graded), trace silt; moist; becomes less weathered with depth (Steilacoom Gravel)
	weathered with depth (Stenacoom Graver)

Test Pit 6 (PIT-6) was initially terminated approximately 4 feet below grade for infiltration testing. After the test, PIT-6 was over excavated to check for high groundwater or immediate groundwater mounding.

No groundwater seepage or mounding was observed during the excavations. PIT-6 terminated approximately 6¾ feet below ground surface in caving conditions.
